INSPECTION REPORT

WITCHES WOODS LAKE DAM CT DEEP #16907

CROOKED TRAIL
BUNGEE BROOK
WOODSTOCK, CONNECTICUT

MARCH 2016

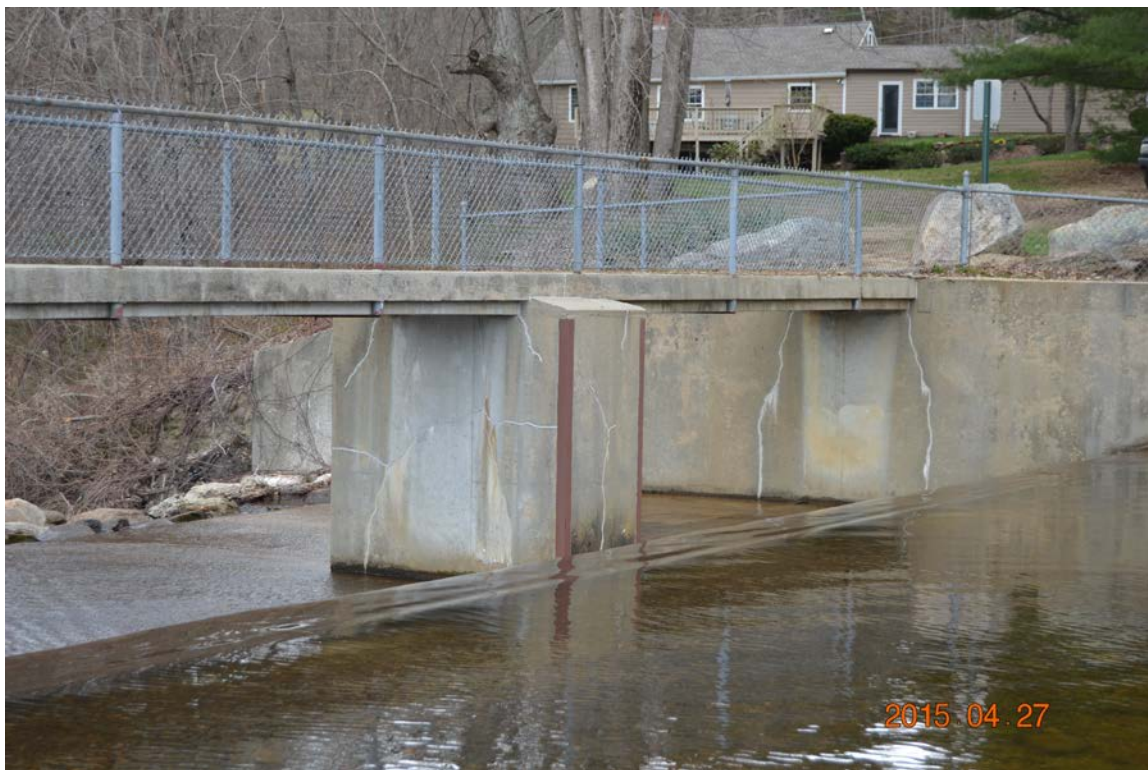
Concrete Condition: Good. Minor cracks and spalls were repaired in 2012, and patches and sealant were still in good condition and holding well.

Cracks: Past cracks had been patched and sealed and, as noted above under concrete condition, were still holding well.

Photo 11a – The right training wall of the spillway as seen from the left upstream side. Note that crack lines along the faces of the walls and the bridge support piers, as seen in this and other photos of the spillway concrete surfaces, are actually filled with sealant. Cleaning and sealing of cracks along these surfaces was accomplished in 2012.

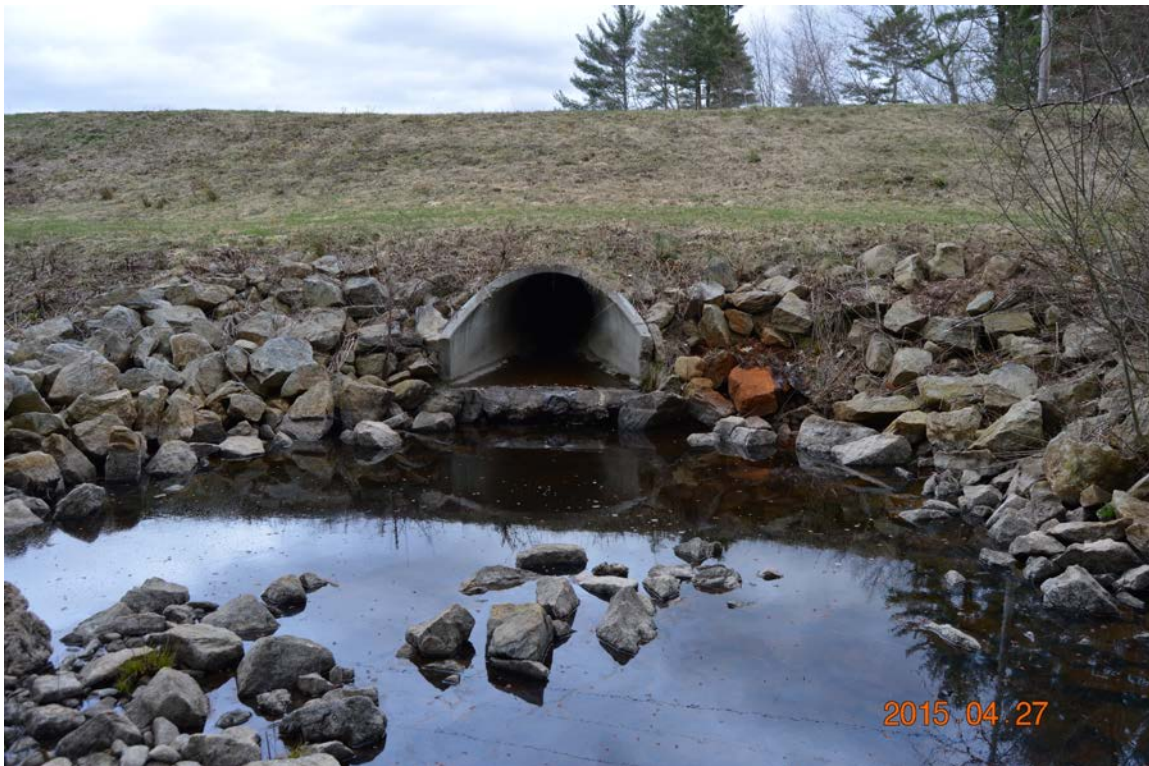
Scouring / Undermining: Minor scour observed within the downstream plunge pool, most likely from high flow discharges. No action recommended at this time.

Photo 19b – A view looking upstream at the flared end pipe discharge point for the low level outlet pipe. There is no formal inlet point other than the structure previously shown at the water's edge in Photo 16.

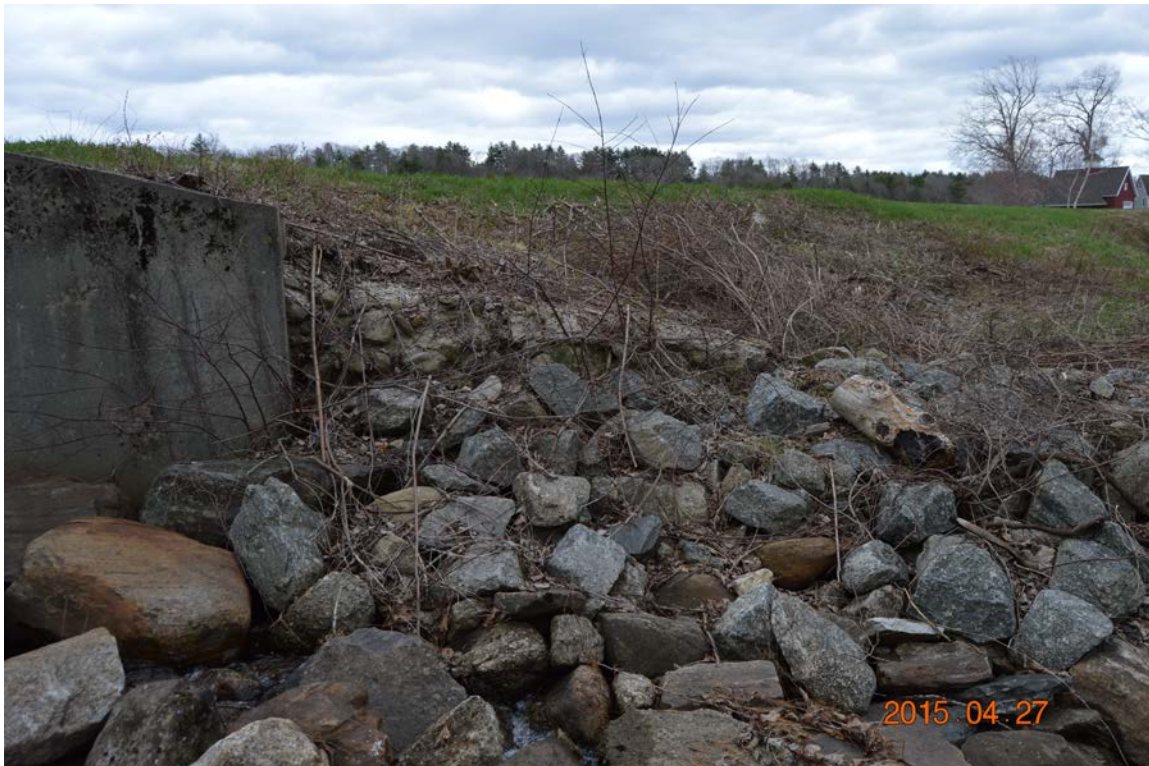
Photo 21a – The open riprap along the stilling basin area of the spillway creates an environment predisposed to the growth of dense brush and small tree growth within its open joints. Although tedious, these areas should be monitored and kept clear of such growth. This view looks toward the end of the left downstream spillway training wall.

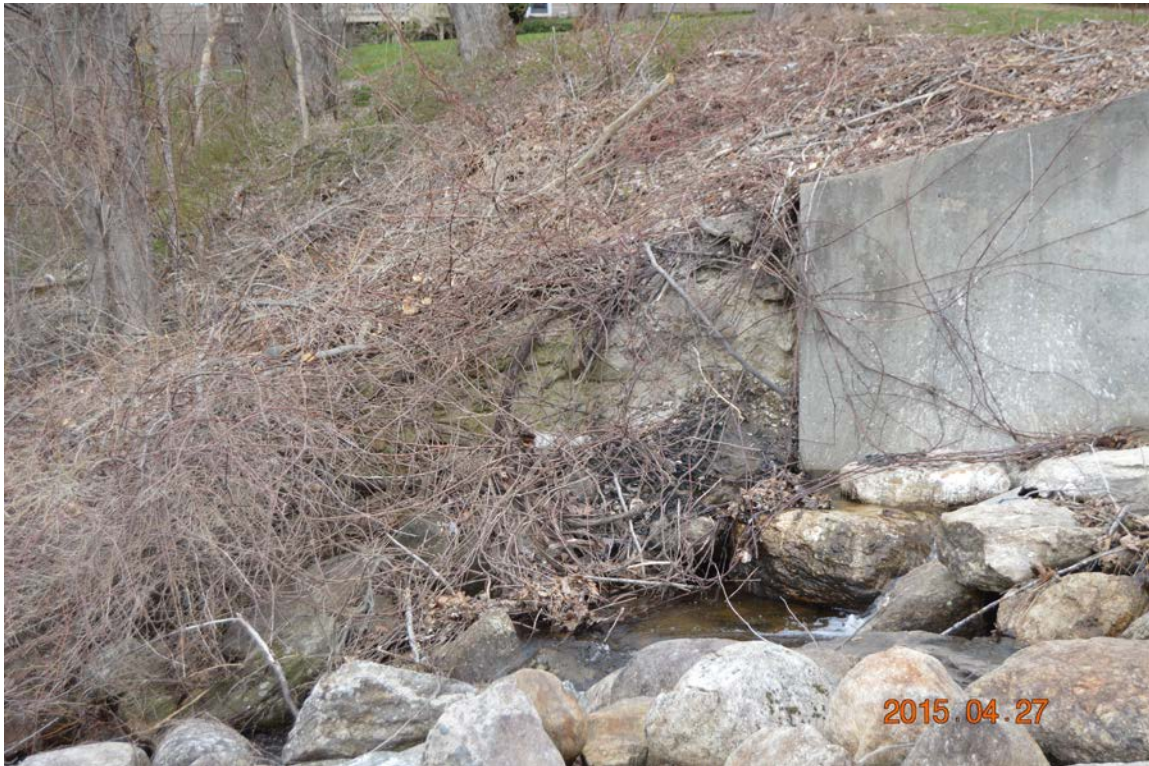
Photo 21b – The same situation with respect to susceptibility for dense growth along open riprap and side slope areas.

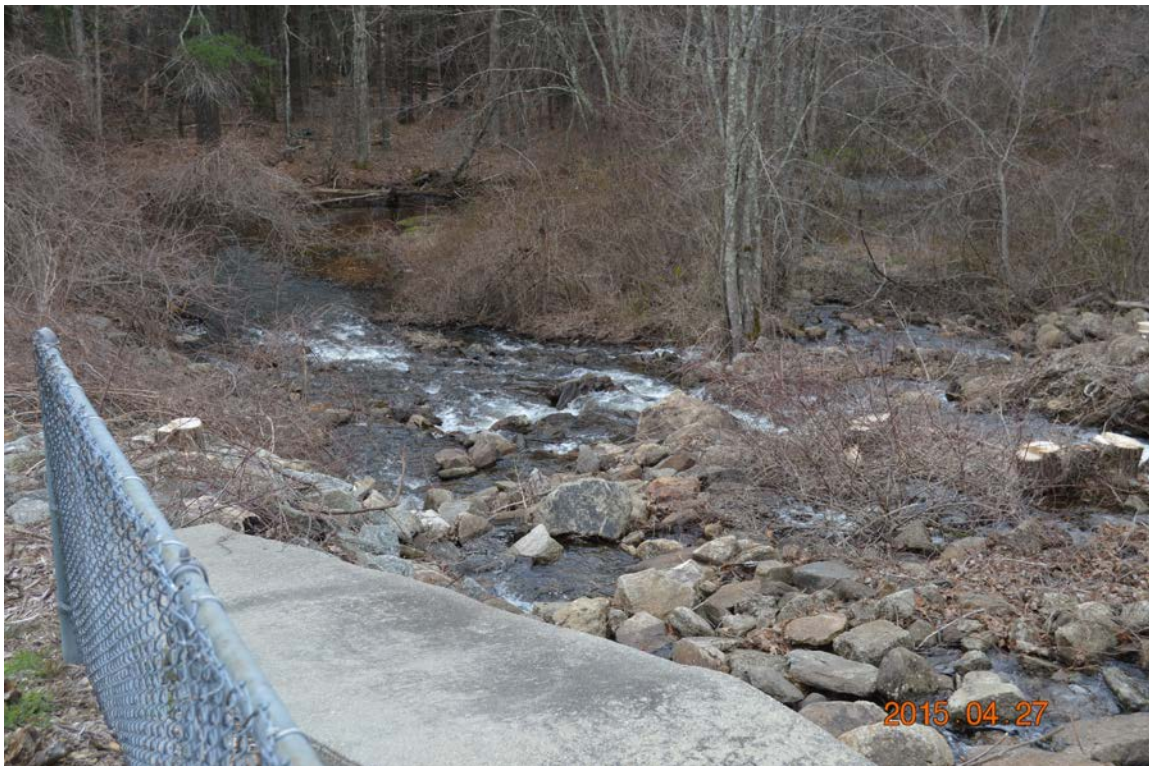
Photo 21c - Several large trees had been removed from the stilling basin area prior to a full inspection of the site, as evidenced by the stumps noted in this photo. Again, this area should continue to be monitored and brush removed on a regular basis.

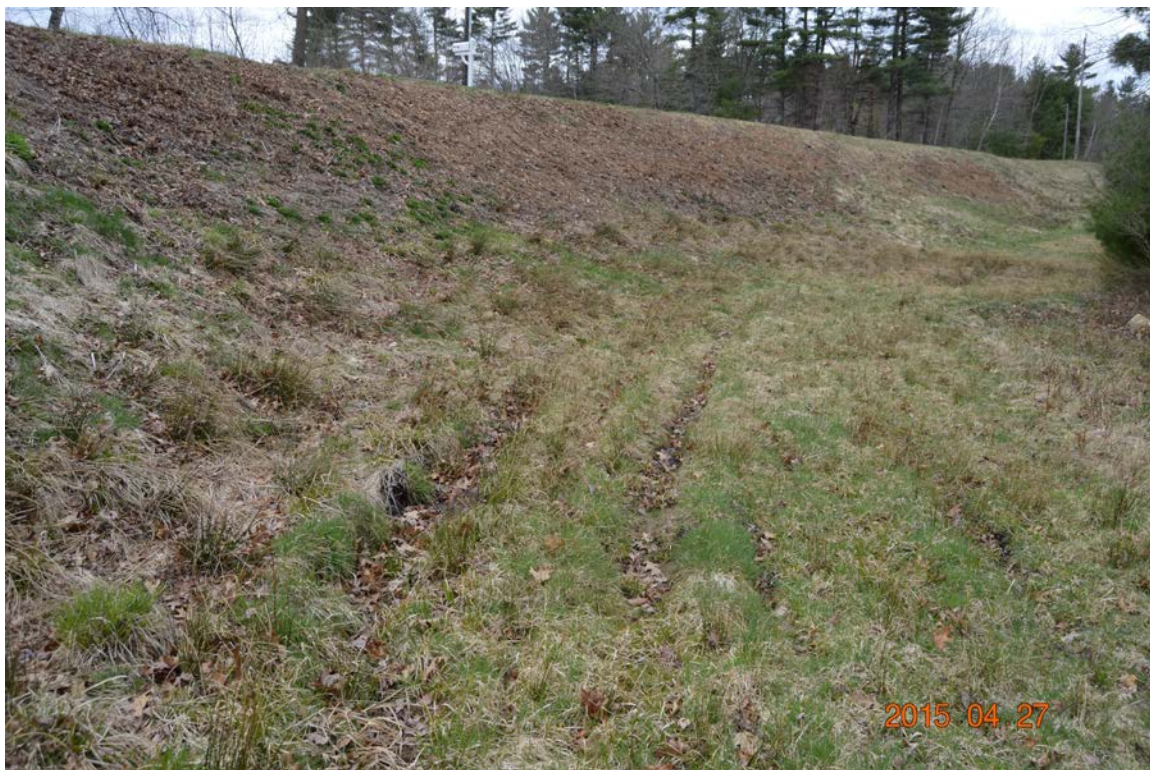
Seepage / Foundation Drainage: Foundation or toe drains, while not included in the original layout of this dam, were later designed and installed along two wet and susceptible areas of the downstream embankment in the vicinity of the sharp bend approximately 400 to 600 feet left of the spillway. Past records indicated that they were functioning as designed, but have since deteriorated or been damaged by maintenance equipment to the point where there are wet spots and ruts with standing water in the locations noted. Recommendations for action have been included in this report.

Current conditions are such that something has transpired over the past several years since the installation of the drains to render them non-functional as evidenced by the wet and rutted areas noted within this report. A physical analysis appears to indicate that at least some of the issues are related to potential damage of the underdrain system by maintenance equipment over both shallow fill materials and shallow piping not designed to carry their loads. (See Photos 21j through 21l for shallow outflow areas.)

Photo 21d – A wet and rutted area near the right side of the sharp bend in the main embankment.

As such, a recommendation is made to survey the area for current elevations and, to the extent possible, locate and delineate the prior underdrain field areas. The most likely method of resolving this situation may be to remove existing materials, reinstall a new underdrain system and then prepare maintenance guidelines to avoid the use of heavy equipment over the new installation.

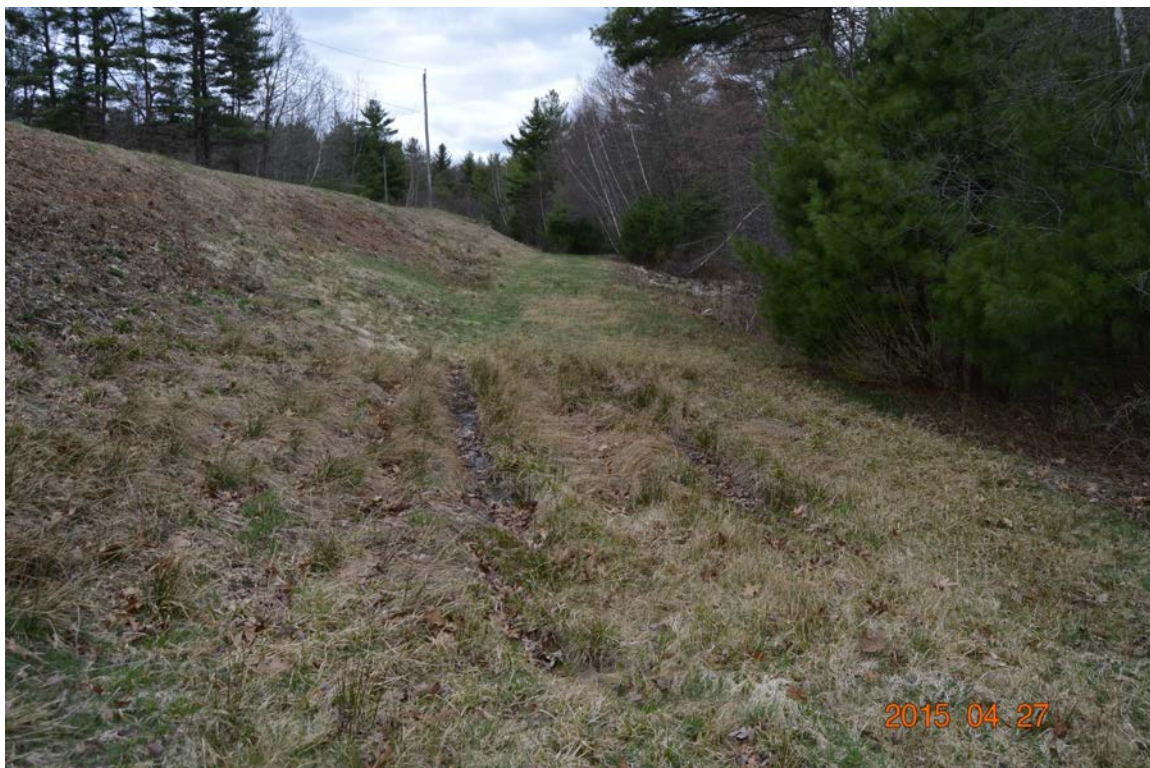
Photo 21e - Another wet and rutted area just beyond the one shown in the previous photo.

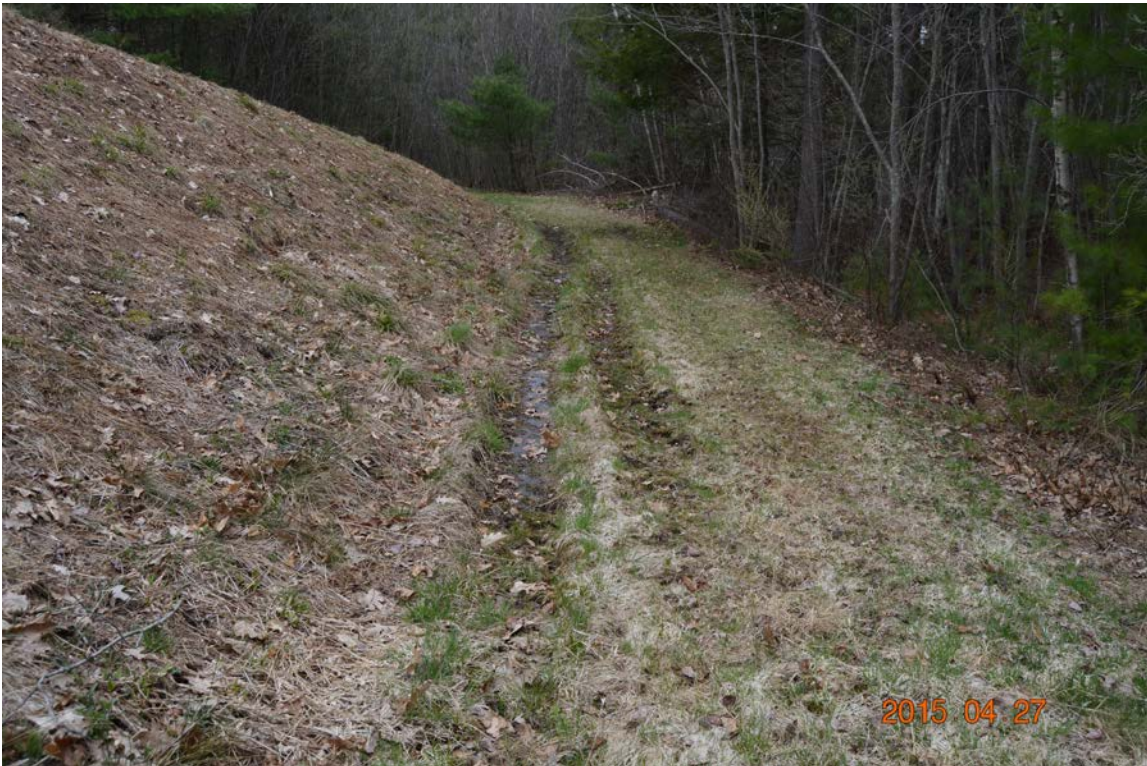
Photo 21f - A wet and rutted area near the left downstream end of the main embankment and just beyond the discharge point of the low level outlet.

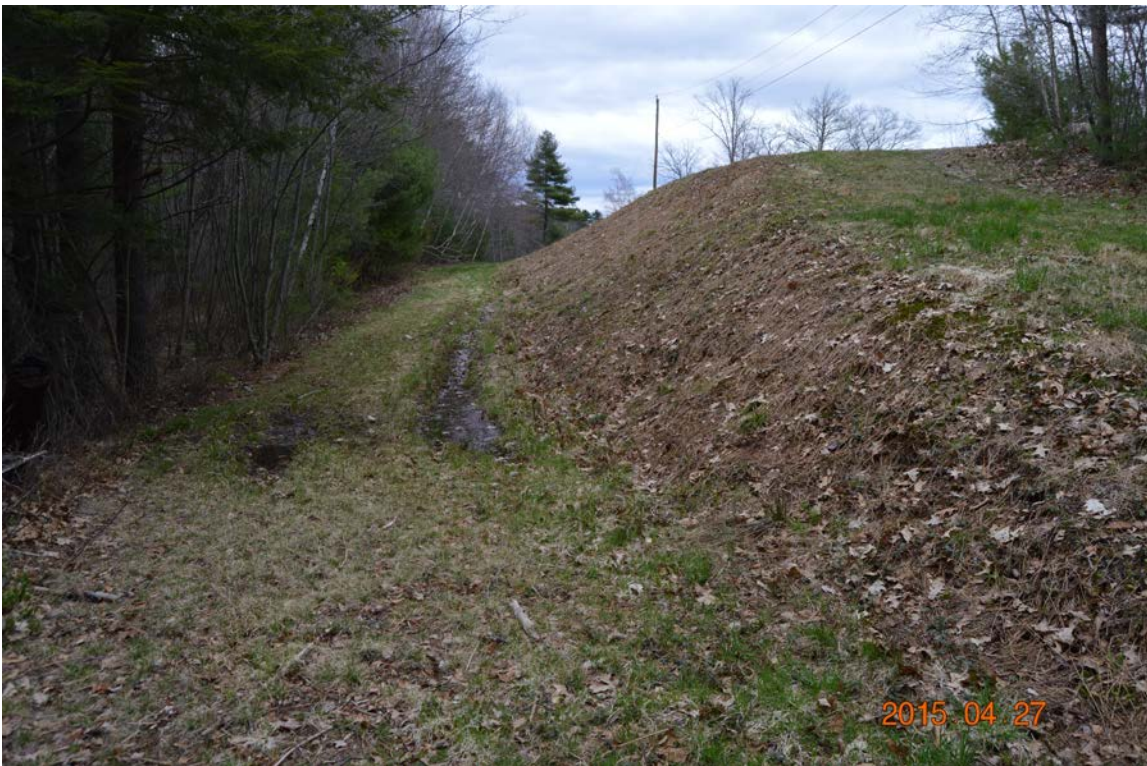
Photo 21g – This wet and rutted area is just beyond that shown in the previous photo, close to the left end of the main embankment.

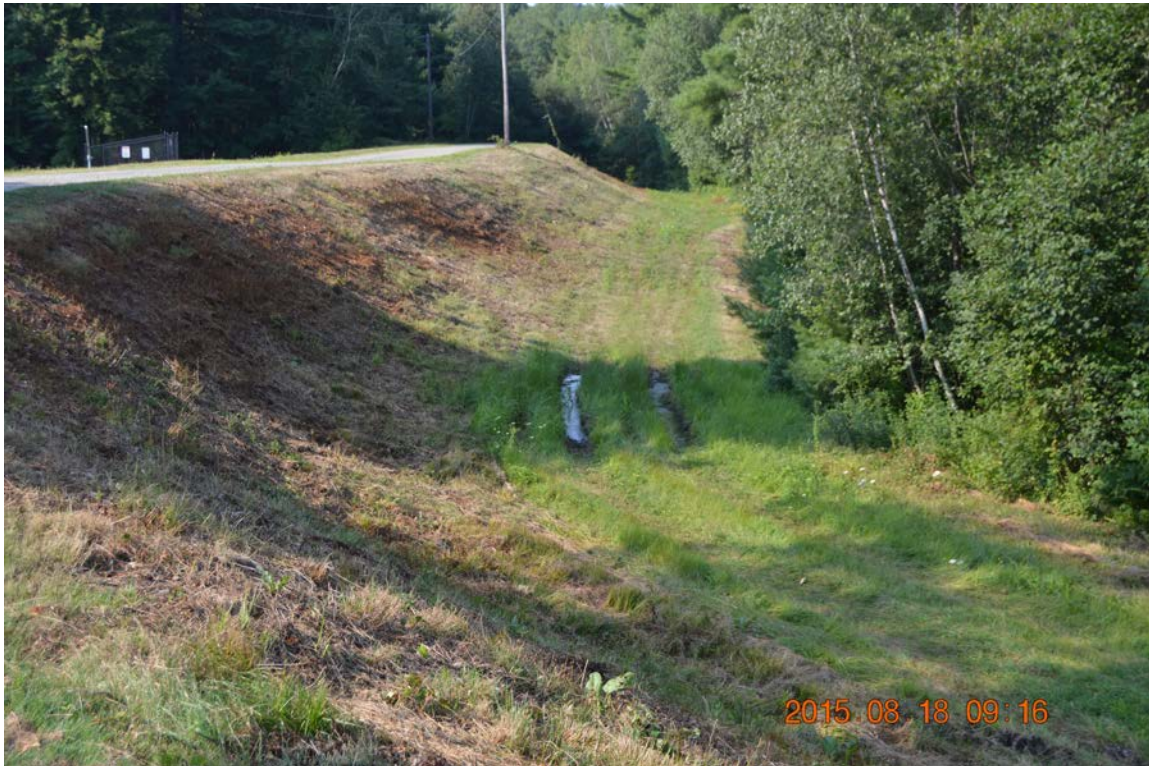
Photo 21h – The same wet and rutted area as shown in Photo 21e, but at a later date and a lower water level. Note that these wet areas persisted even with changes in water levels within the lake.

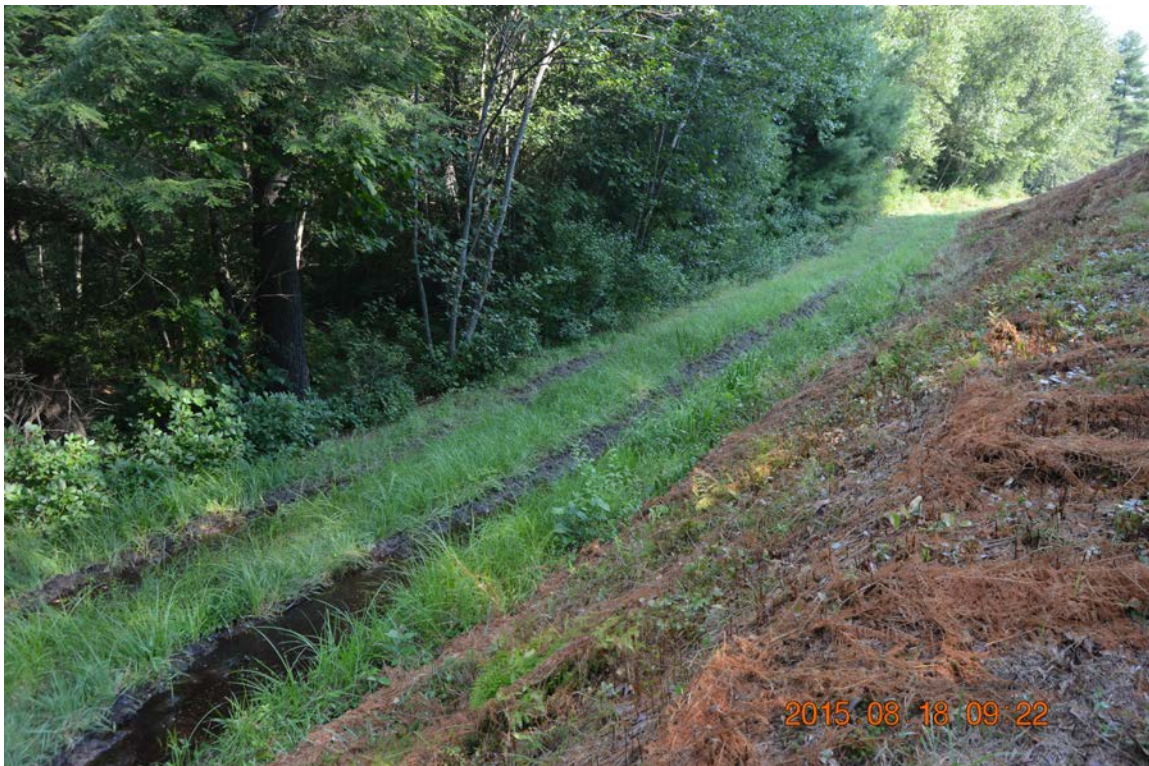
Photo 21i – The same wet and rutted areas noted in Photos 21f and 21g, this time tied together in a continuous stretch toward the left end of the main embankment. Note again the difference in saturation even with a lowered water level in the impoundment.

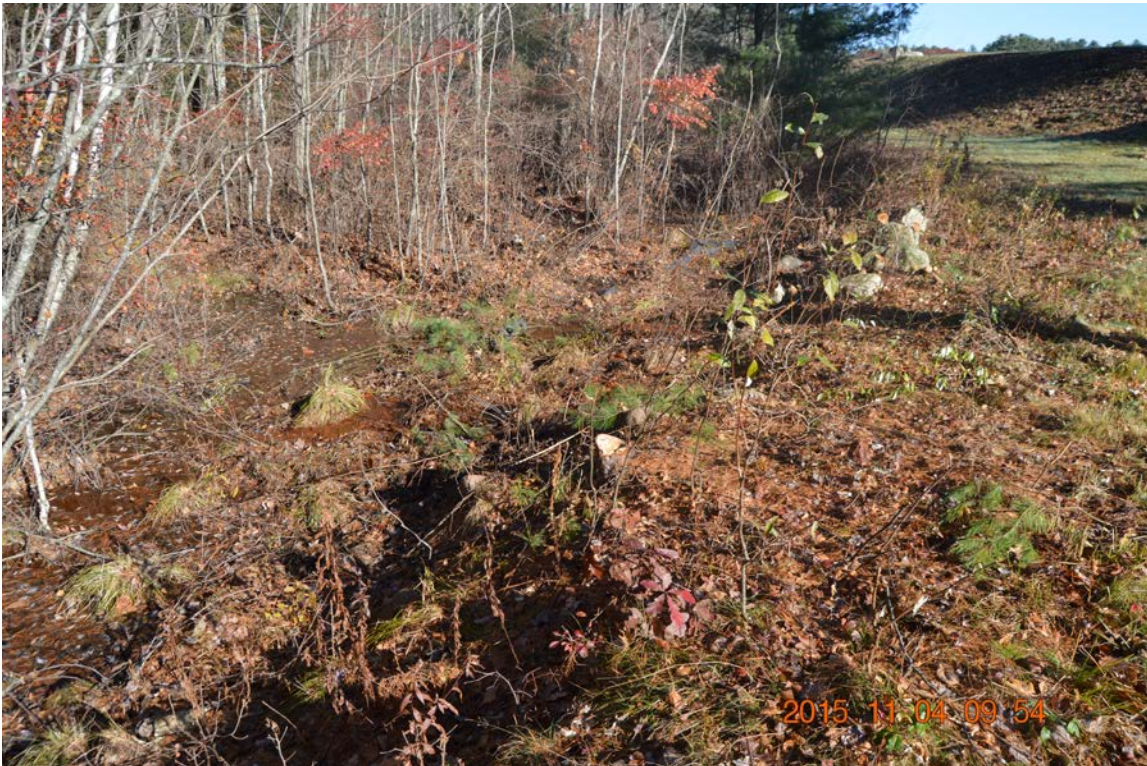
Photo 21j – An outlet from toe drains presumably installed or repaired in 1996, situated in the vicinity of the sharp downstream turn in the main embankment of the dam. Note the reddish stain indicative of a discharge characteristic of iron bacteria emerging from an anaerobic environment (e.g. within or below the embankment) to aerobic conditions, i.e., exposed surface water areas. Note also that in this area there is very little elevation difference between the downstream grass shelf and the adjacent wetlands.

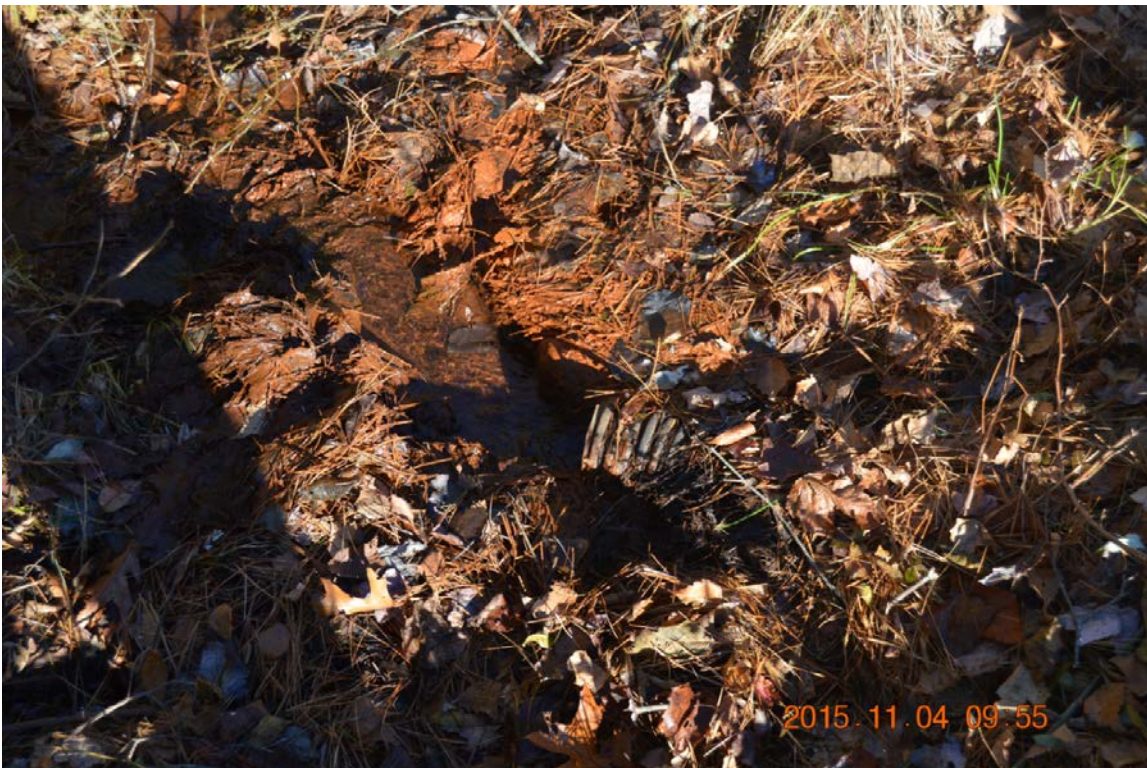
Photo 21k – One of the old toe drain discharge points at the edge of the shelf and wetland area in the vicinity of the sharp curve on the downstream side of the main embankment.

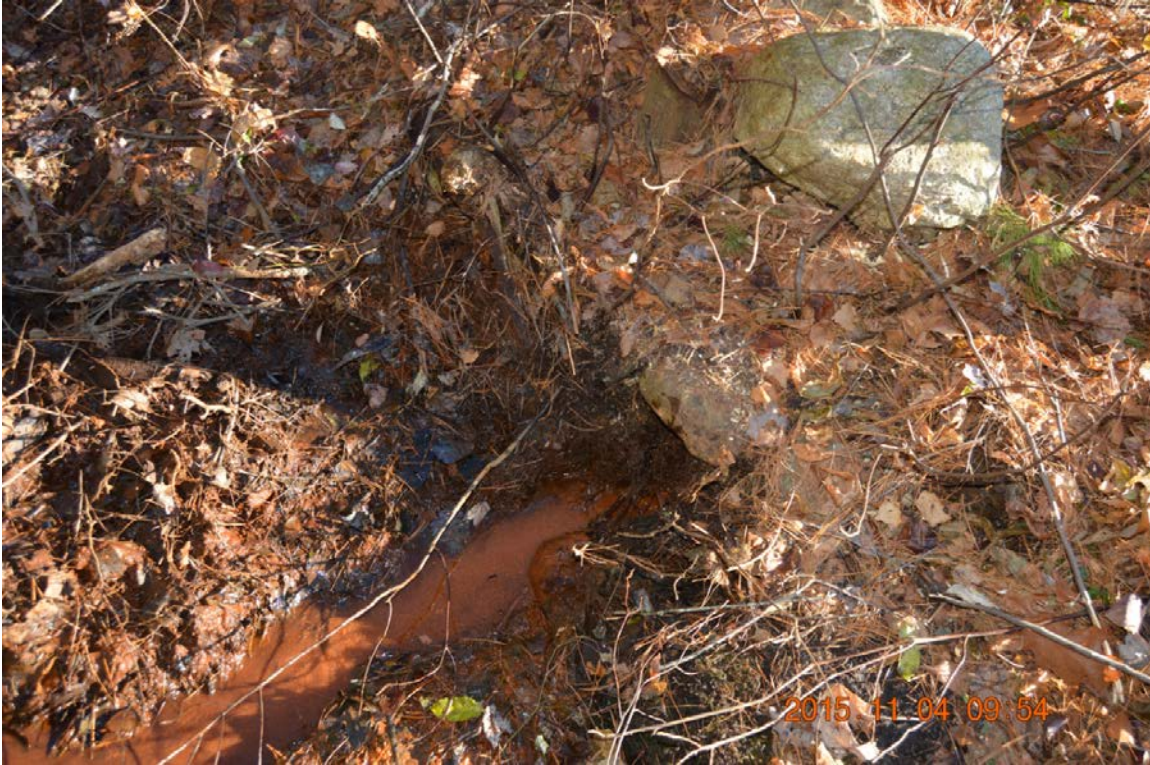
Photo 21l – Another toe drain discharge just north of the one shown in the previous photo, but without a visible pipe outlet.

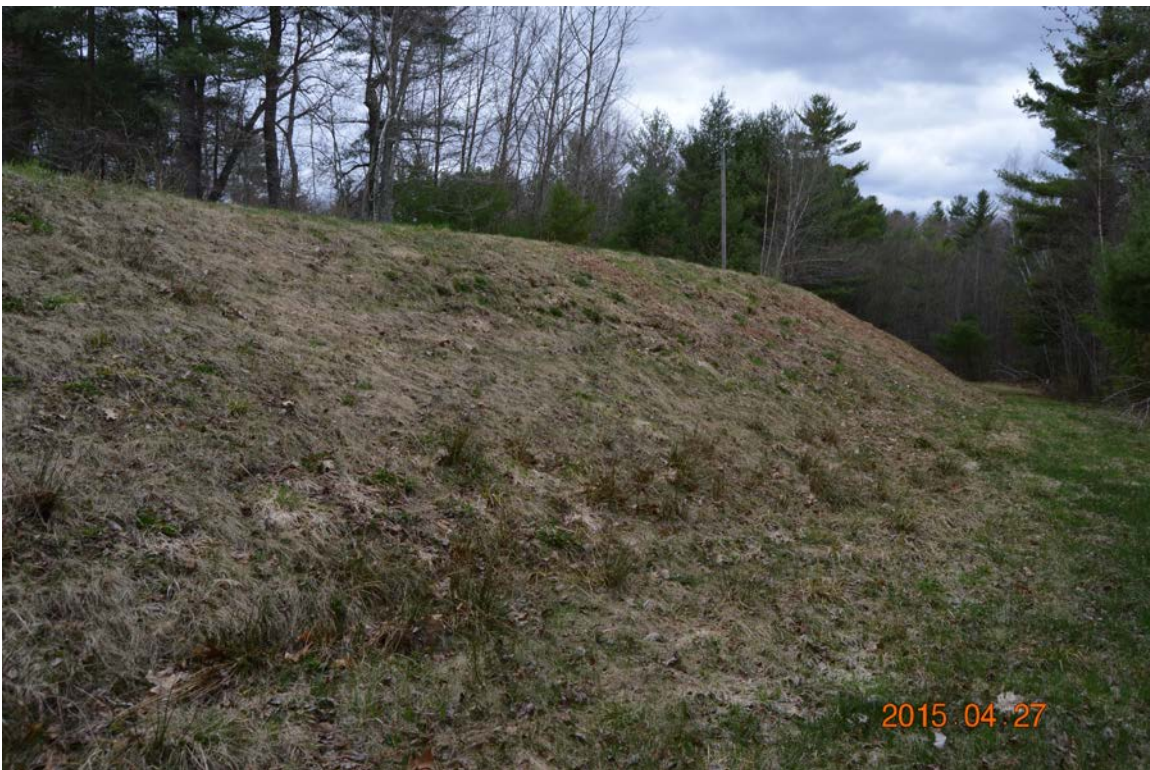
Settlement / Alignment / Movement: Two small areas of minor mower damage and potential sloughing were noted approximately 200 feet and 800 feet left of the spillway on the downstream side of the earth embankment. These areas are not a safety issue at this time, but recommendations with respect to maintenance have been included in this report.

Photo 21m – A small area along the left section of the main embankment in the vicinity of the low level outlet area showing signs of what appears to be minor sloughing.

3. **Damaged Slope Areas** – As noted in the report and pointed out in some of the photos, a small number of areas of the dam show signs of damage from maintenance equipment and minor sloughing. These areas should be repaired by placement of small amounts of fill and regrading where necessary to reestablish firm slope conditions. Where appropriate and as necessary, these areas may require the placement of slope stabilization matting. For future maintenance, instructions should be given to maintenance personnel to avoid traversing the slope with large or heavy equipment that could tear the embankment and lead to potential sloughing or slope stability issues.

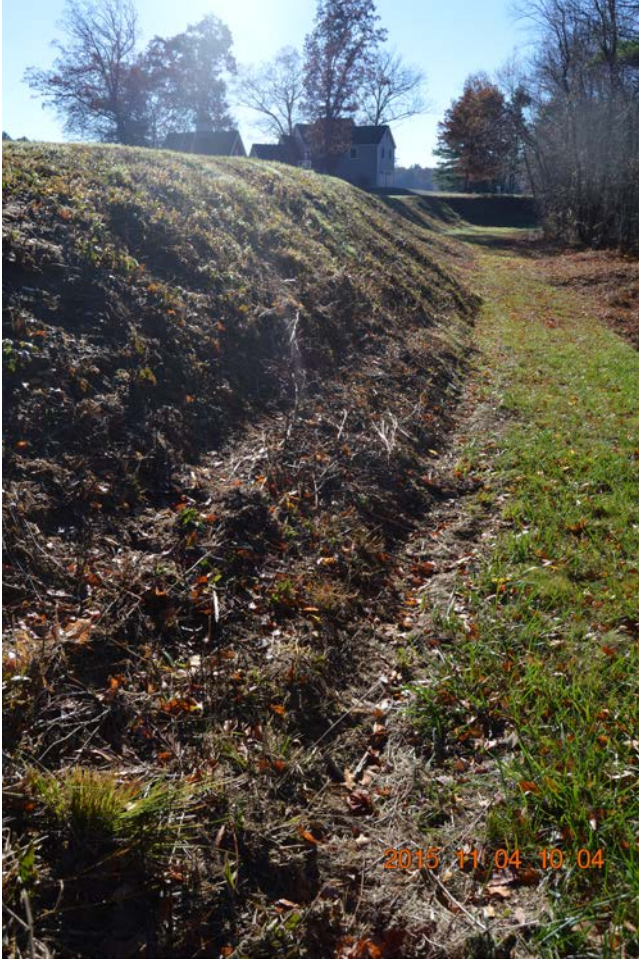
Photo 21n – An area showing what appears to be damage from mowing, as shown by the wheel ruts along the base of a steep slope section. Such areas could become susceptible to sloughing if not properly maintained.
