INSPECTION REPORT

WITCHES WOODS LAKE DAM CT DEEP #16907

CROOKED TRAIL
BUNGEE BROOK
WOODSTOCK, CONNECTICUT

MARCH 2016

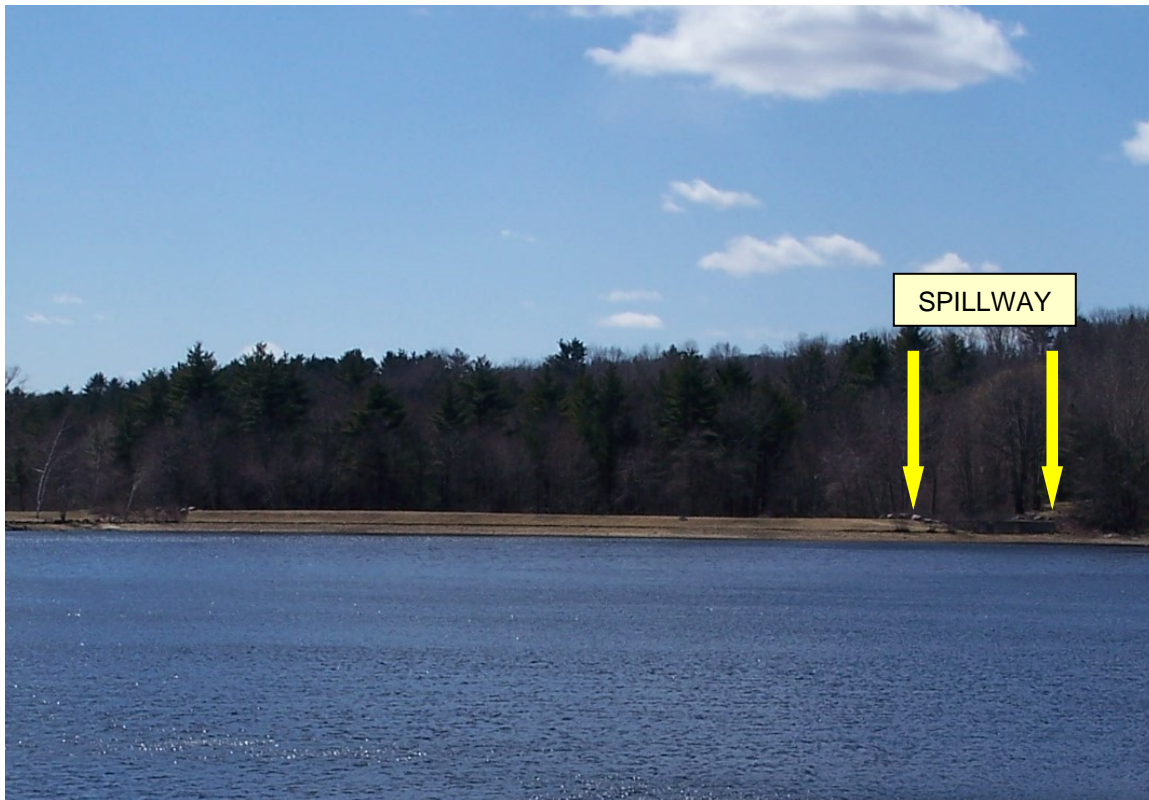
Photo 1 – The dam at Witches Woods Lake as seen from the upstream, looking south. The spillway, with extents shown by the yellow arrows, is situated directly adjacent to the right abutment of the dam. The dam itself, an earth embankment dam, extends out beyond the left side of the photo.

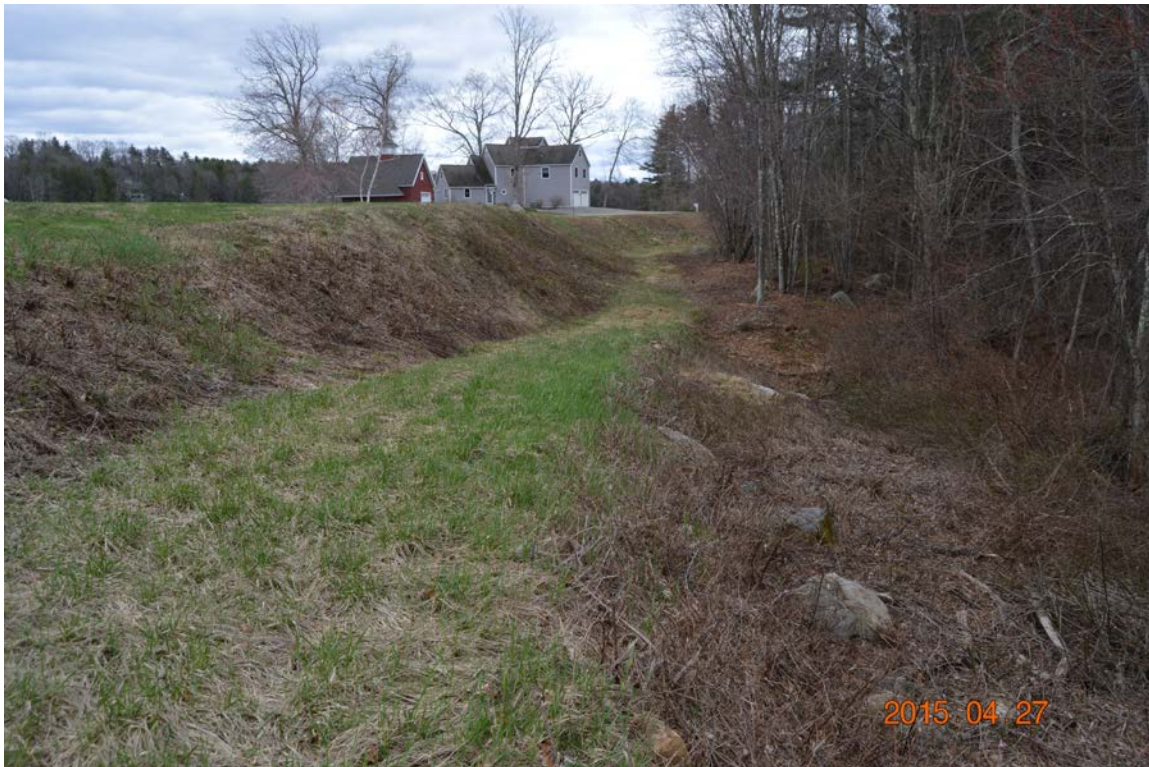
Photo 2 – The dam as seen from the downstream side and from the left side of the spillway. Because of the length of the dam and the various angles within the embankment, a full downstream view was not achievable for this site.

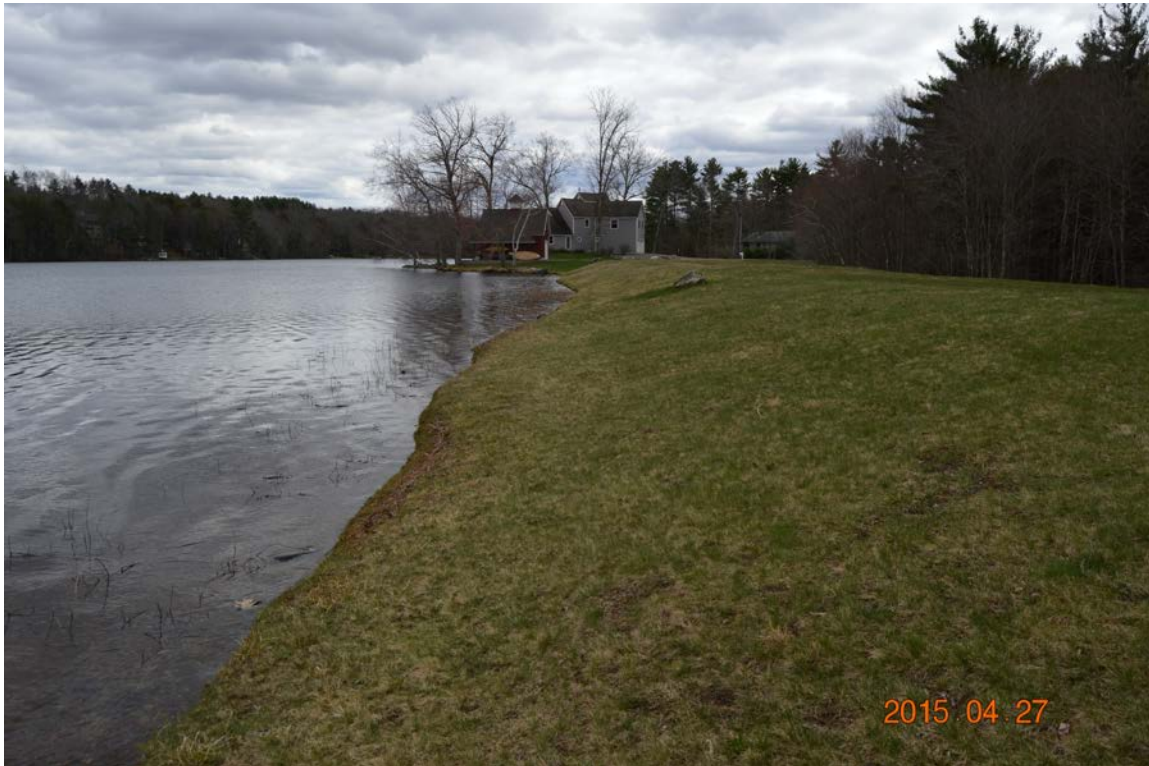
Photo 3a – The upstream face of the dam as seen from the right side of the dam, not including the spillway which is out of view just to the right of the photo. Because of the angularity of the dam's layout, some of the views may not be completely in line with the form requirements.

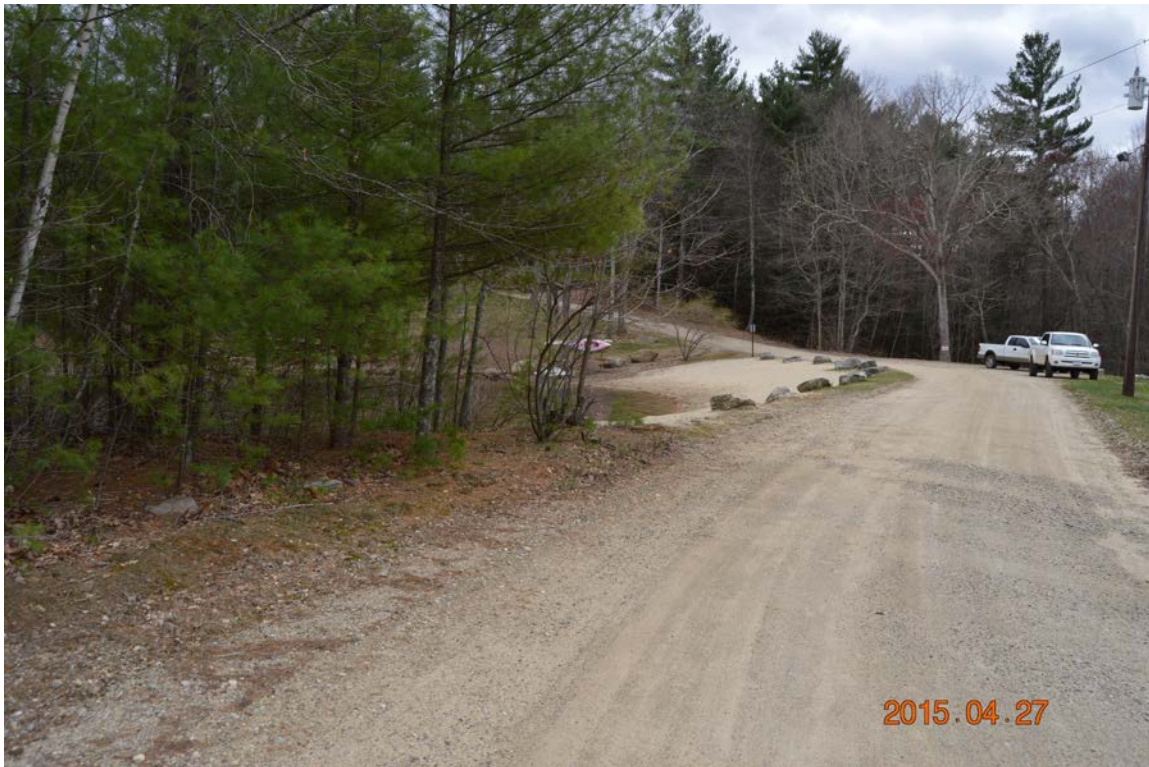
Photo 3b – Looking toward the left upstream and crest of the dike section from the right side, a short section of natural ground area. The lake and a small section of sandy beach area are visible at the center of the photo.

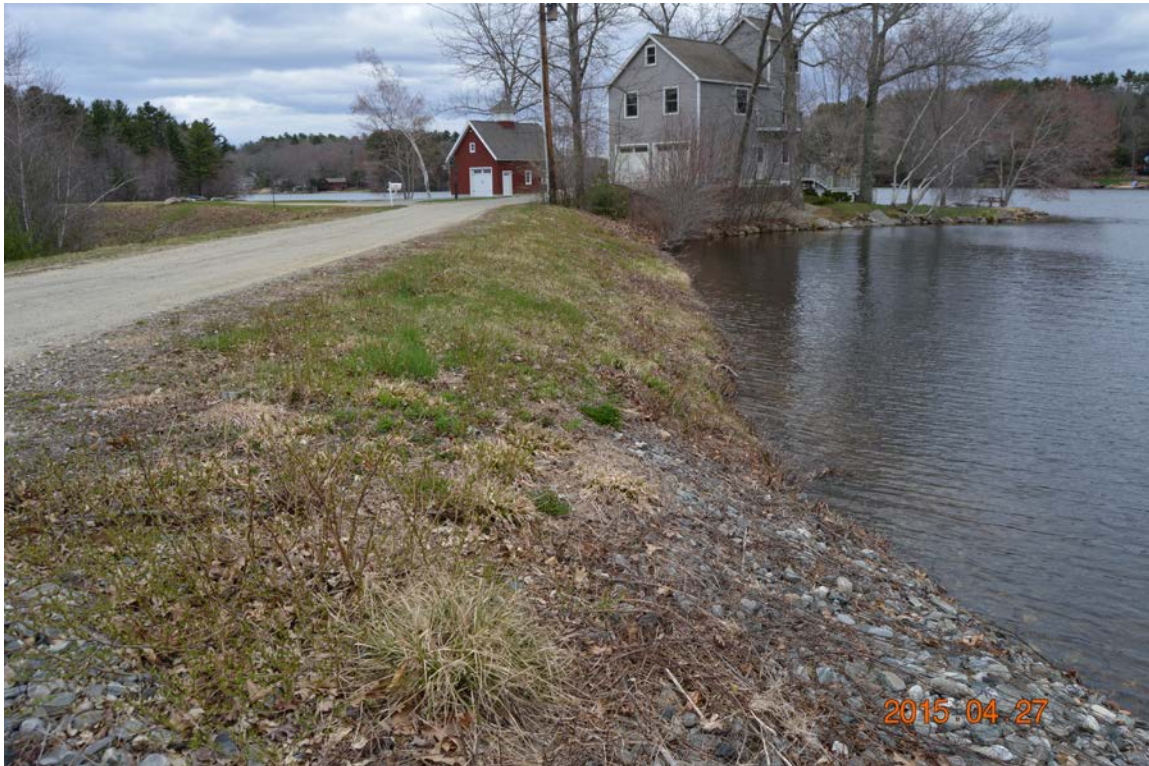
Photo 4a – A portion of the upstream face of the dam looking northerly from the left side of the embankment.

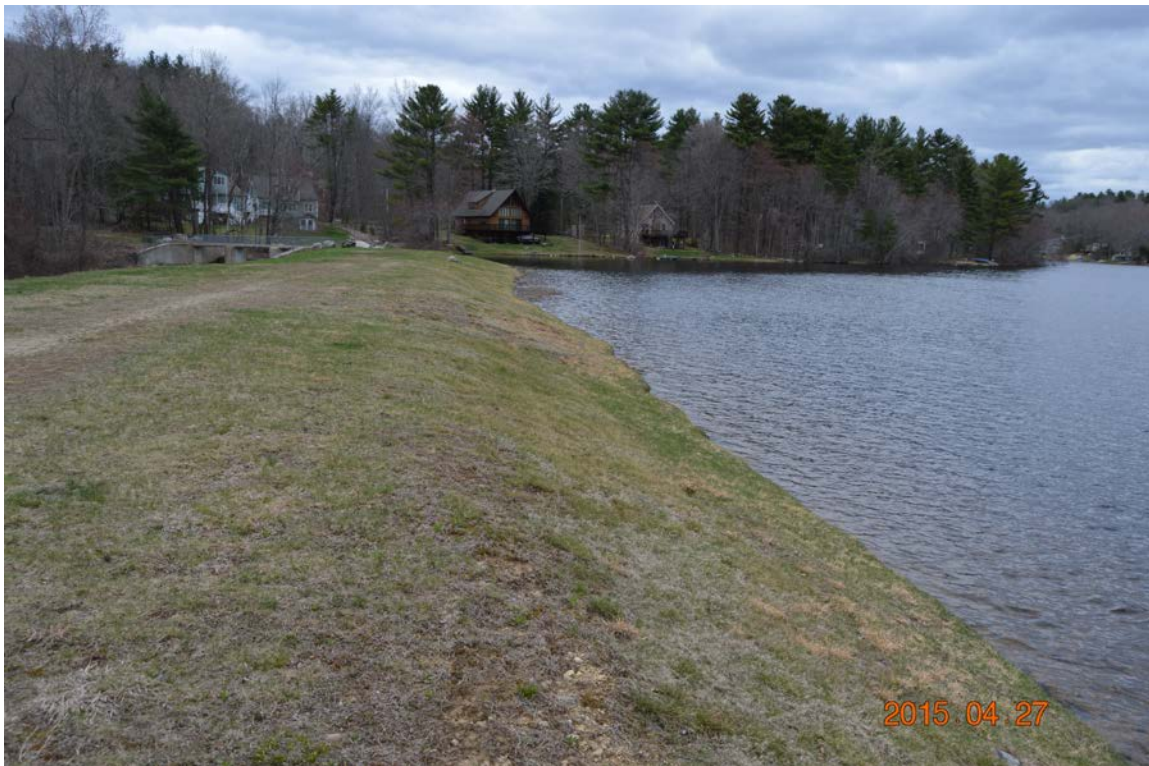
Photo 4b – The upstream side of the dam leading in to the right abutment and spillway area. The viewpoint of this photo was from just beyond the red garage seen in the previous photo.

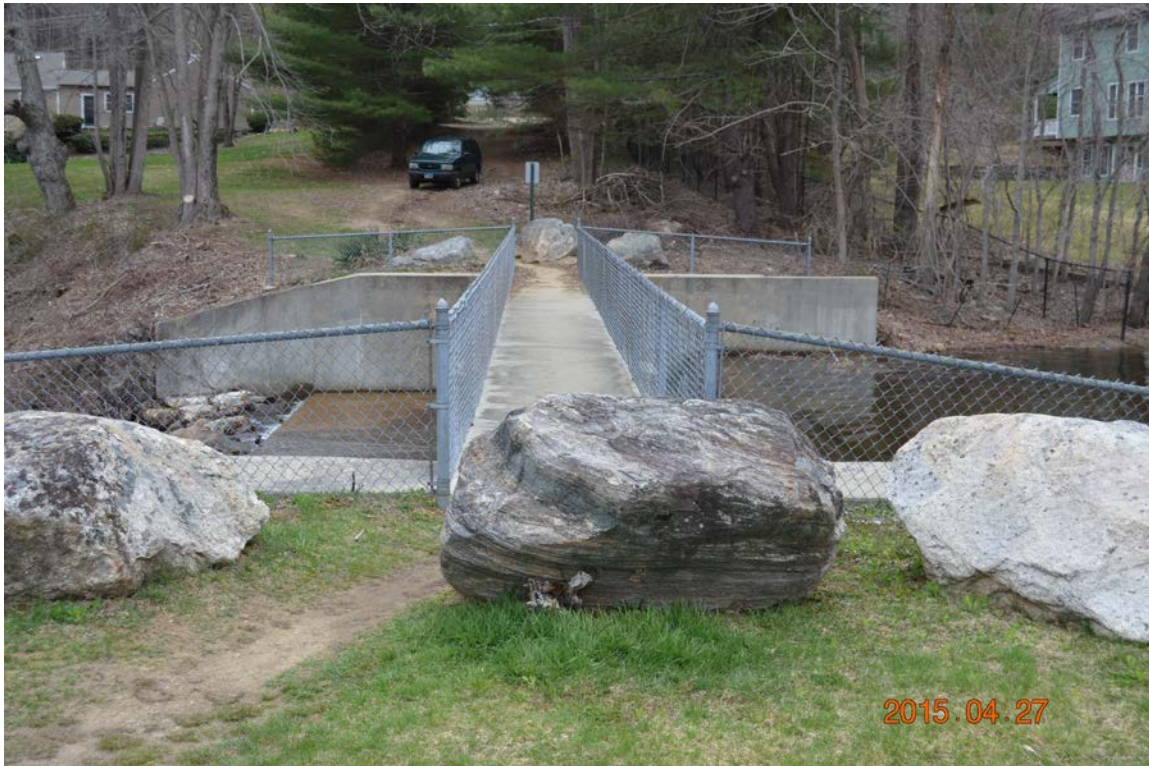
Photo 4c – Looking at the right abutment of the dam from the left side of the spillway. The dam ends directly after the spillway as the ground level rises sharply towards the west.

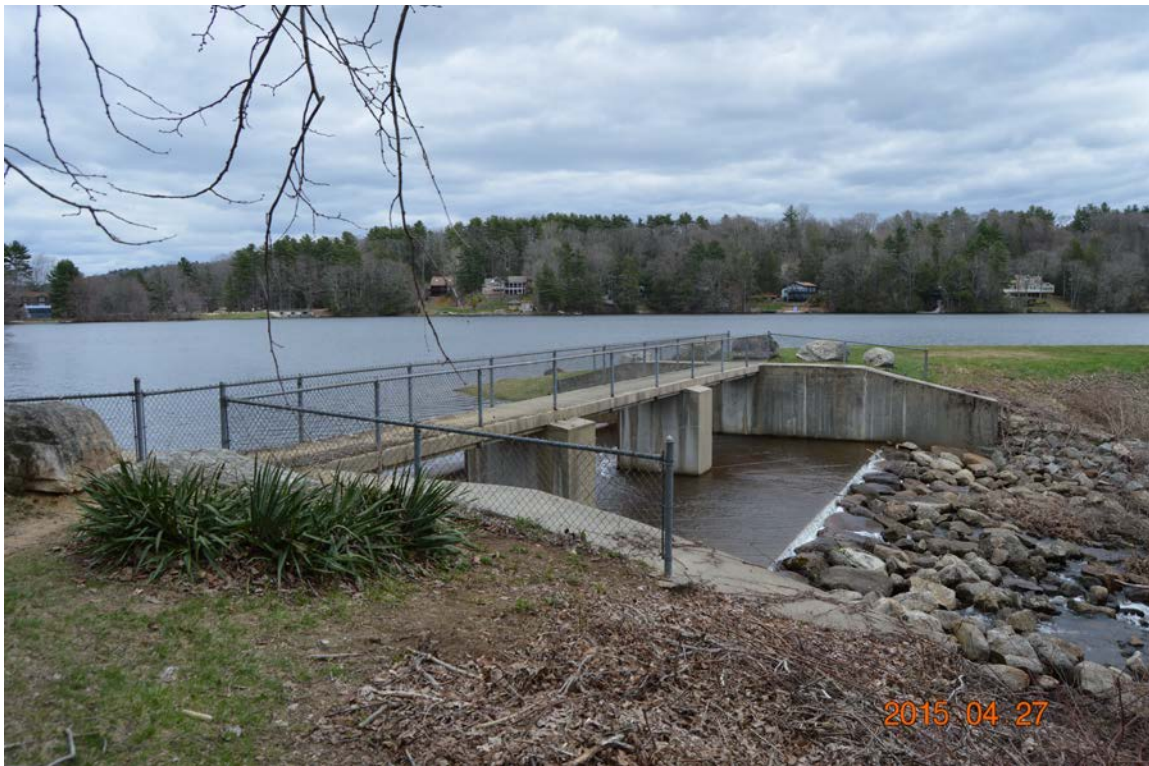
Photo 5a – Looking easterly from the right abutment toward the spillway and the beginning of a long earth embankment section that turns abruptly toward the right after the spillway.

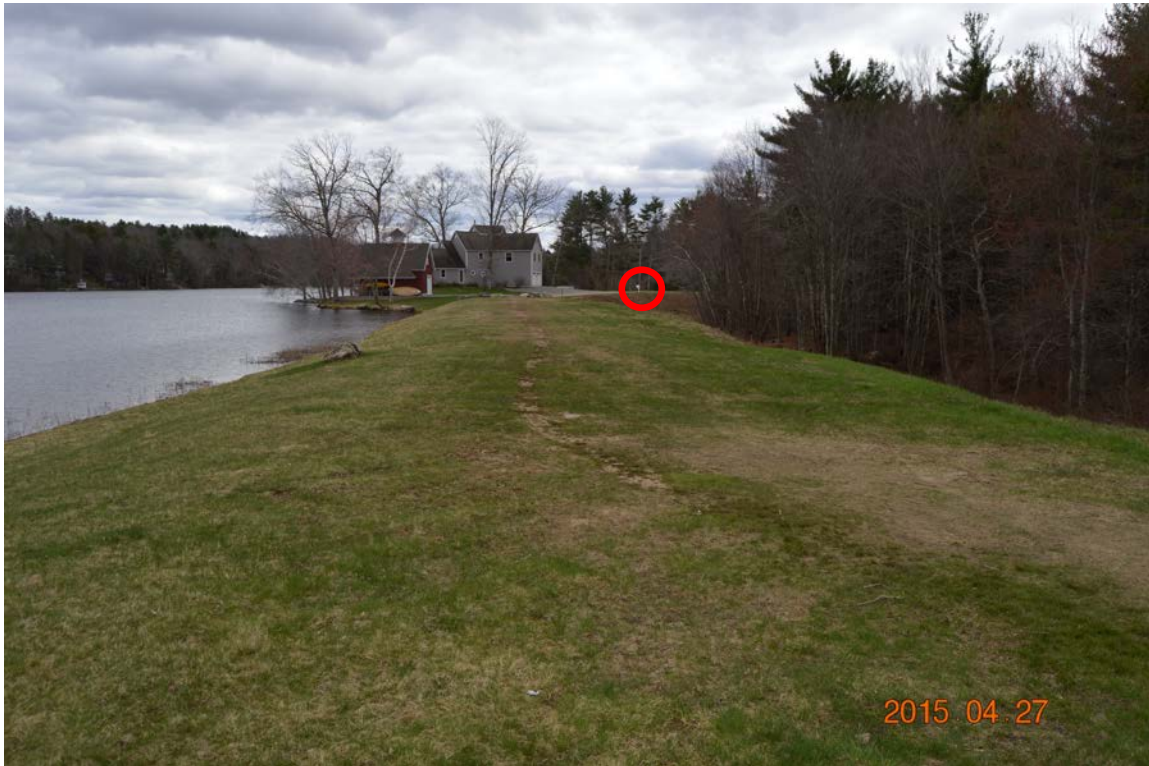
Photo 5b – The crest of the dam looking southeasterly towards a sharp bend (to the right) in the embankment at the house location. The spillway is just behind and outside the viewpoint of the photo (see prior photo). The next photo shows the crest area just beyond the house in the distance, at which point the dam embankment takes a sharp turn to the right.

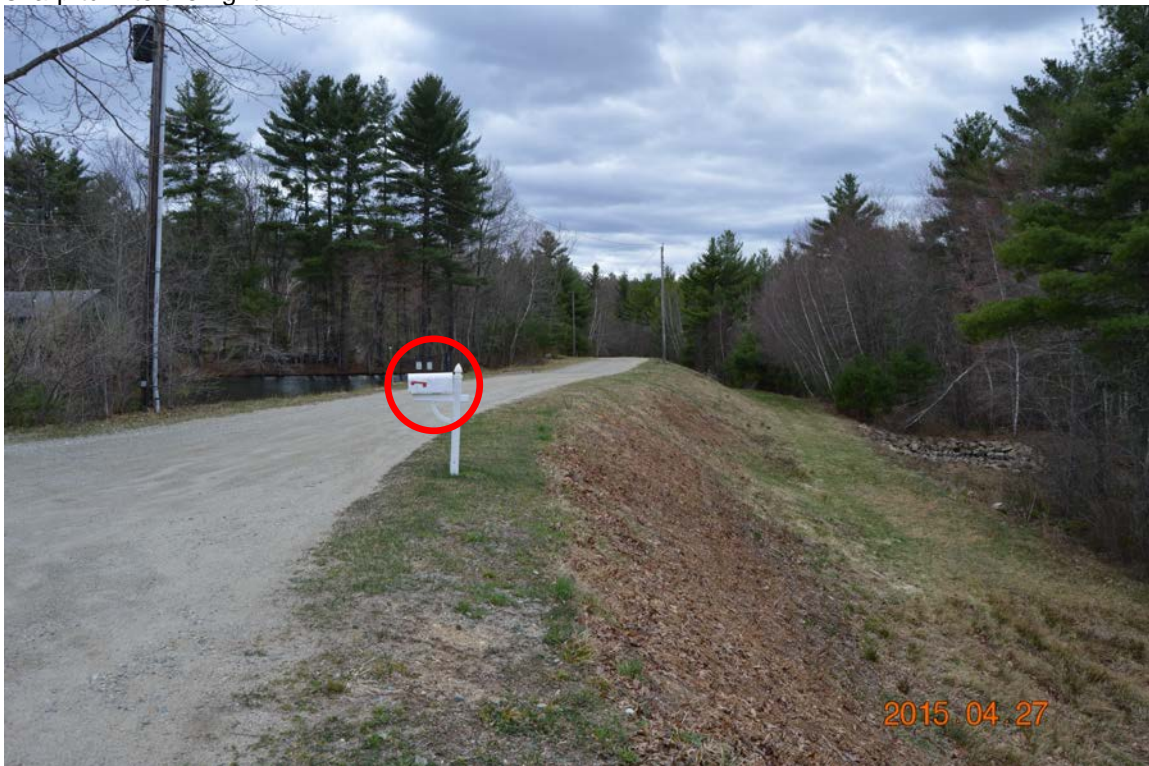
Photo 5c – The crest of the embankment beyond the point noted in the previous photo. The red circle at the mailbox denotes the same point circled in the previous photo. The embankment for this section ends just beyond the viewpoint at the center, after which there is a short section of original ground (see Photo 3b) before the remaining dike section (see following photo).

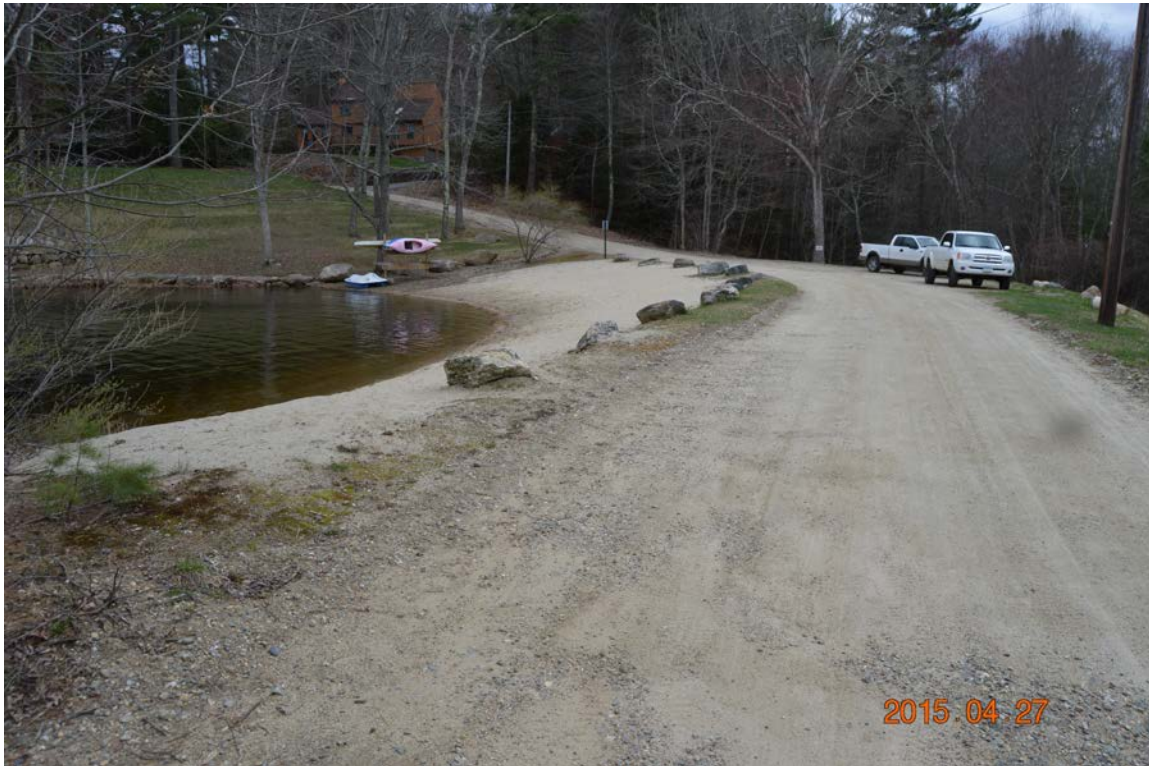
Photo 5d – The crest of the dike (and upstream slope) of the dike section looking toward the left abutment area from the right abutment of the dike.

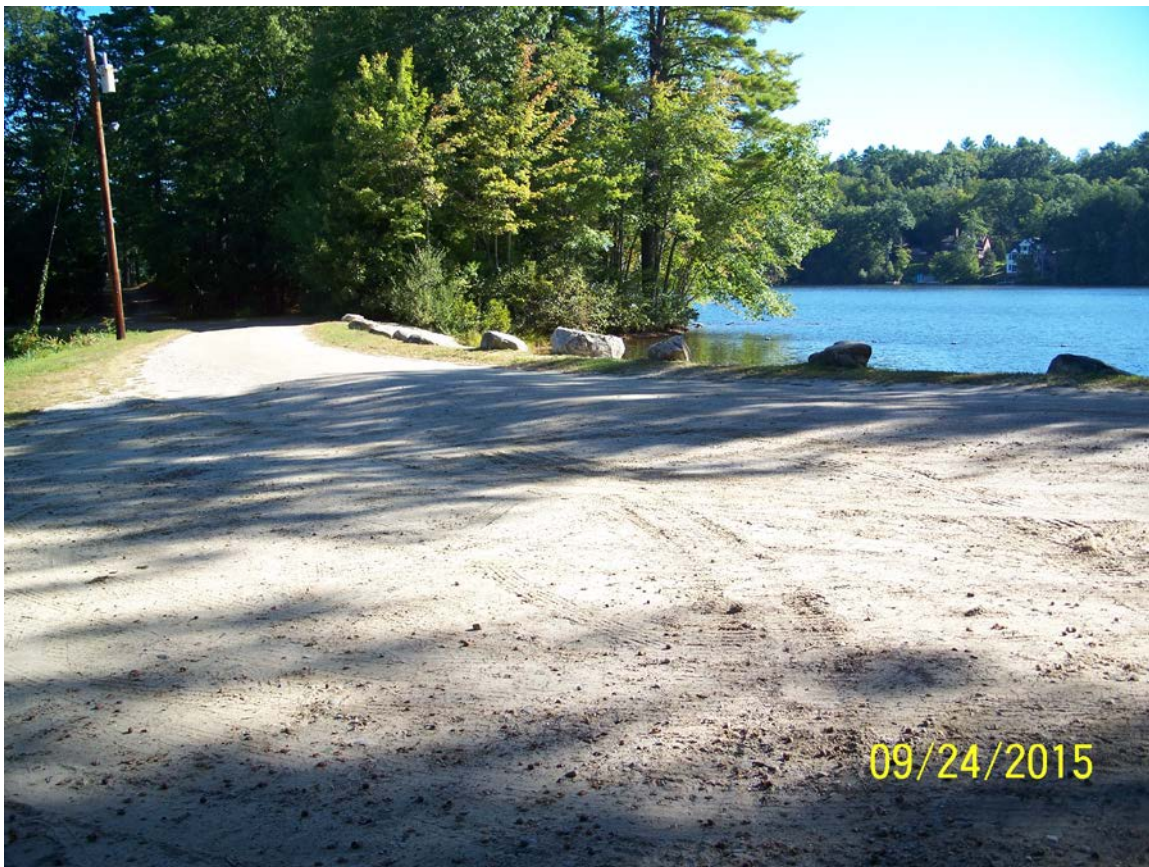
Photo 6a – The crest of the dike as seen from its left abutment area, looking in a northeasterly direction.

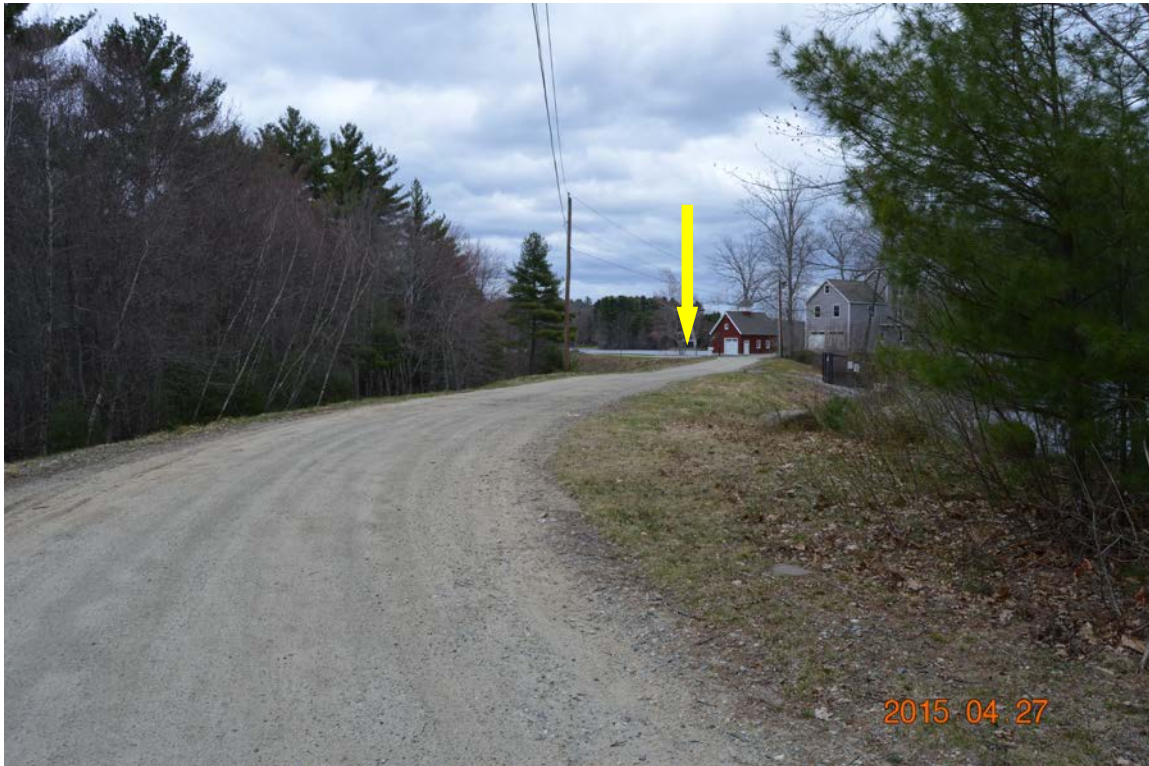
Photo 6b – The main dam embankment, looking northeasterly towards a sharp bend to the left. The vantage point of the photo is from the left abutment, an area of original ground between the dam and dike.

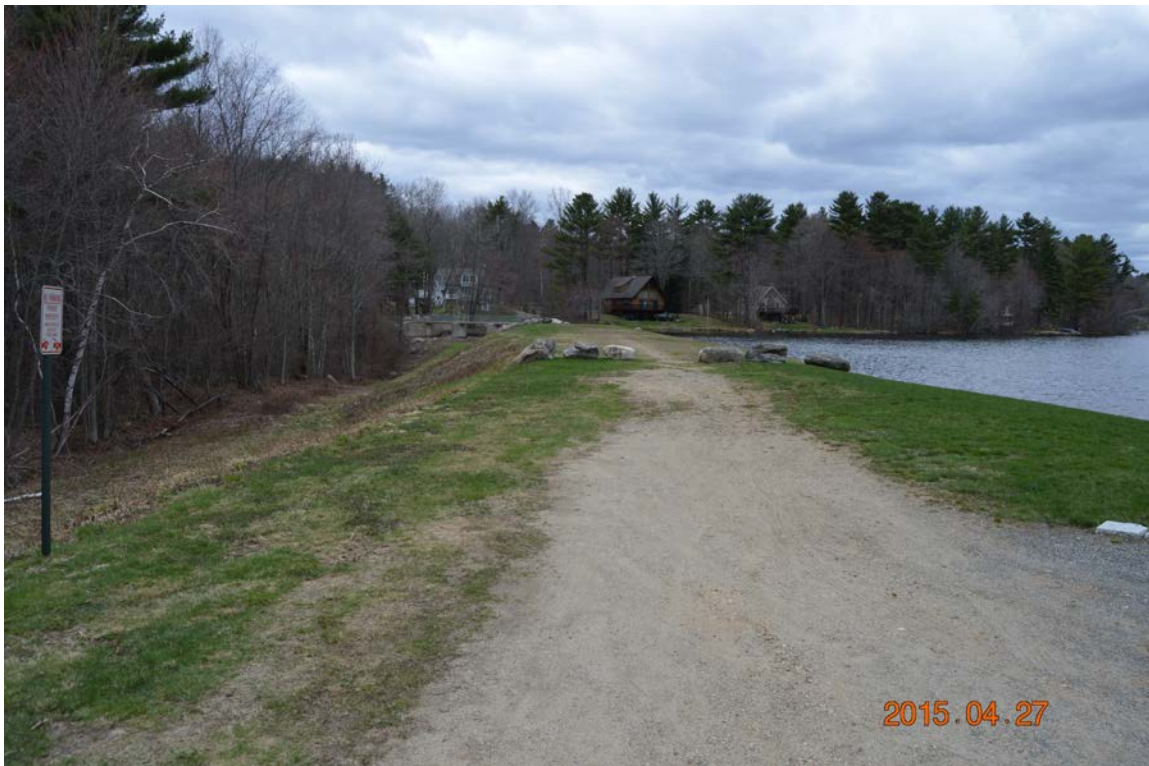
Photo 6c – The crest of the dam looking in a northwesterly direction from the sharp bend in the embankment indicated in the previous photo. The arrow in the previous photo indicates the vantage point for this photo.

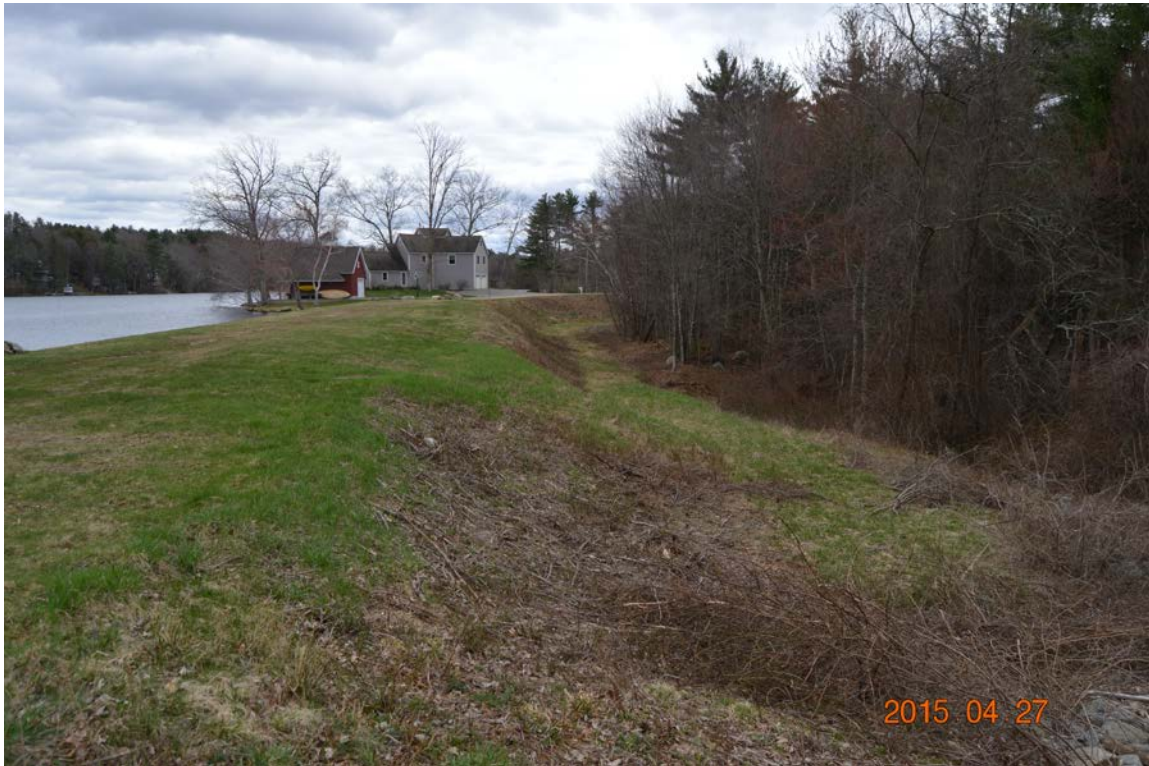
Photo 7a – The downstream face of the main embankment as viewed from the left side of the spillway. Note that there is a shelf along the downstream base of the dam, the height of which varies but has an average drop of about 2 feet across the length of the dam.

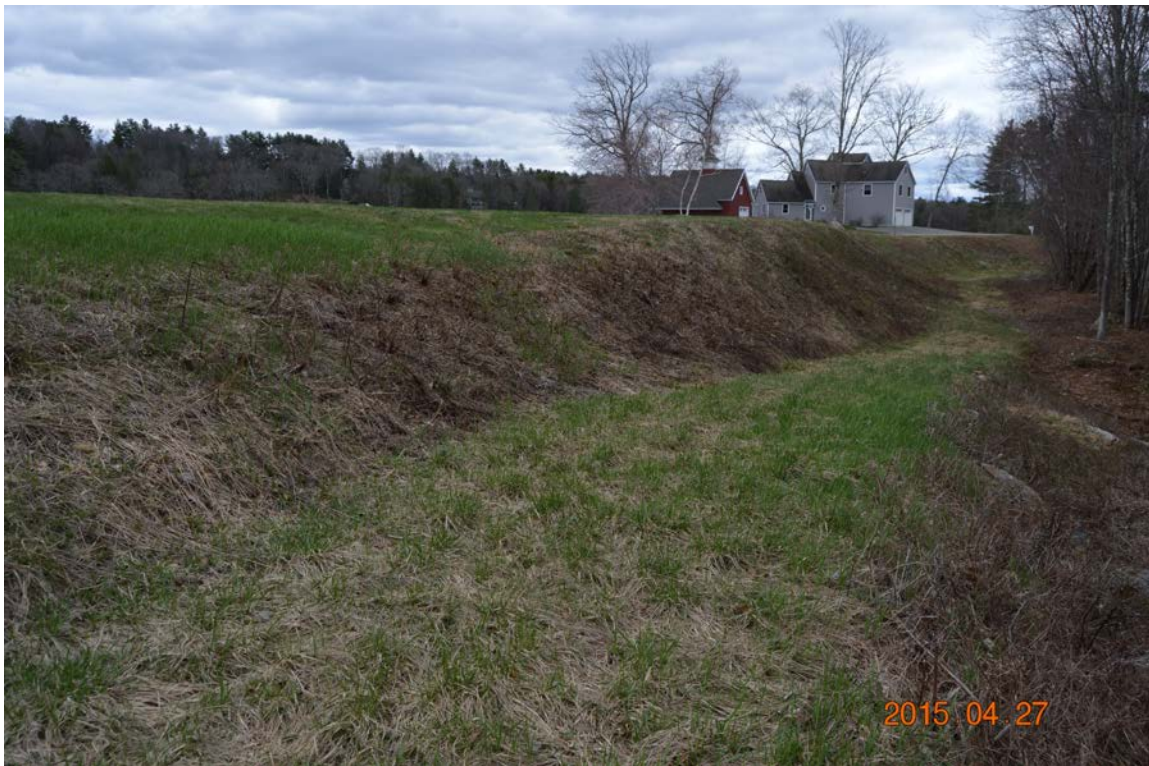
Photo 7b – Another view of the downstream embankment slope as seen from the base shelf along its right side, looking toward the sharp bend toward the right at the house in the distance.

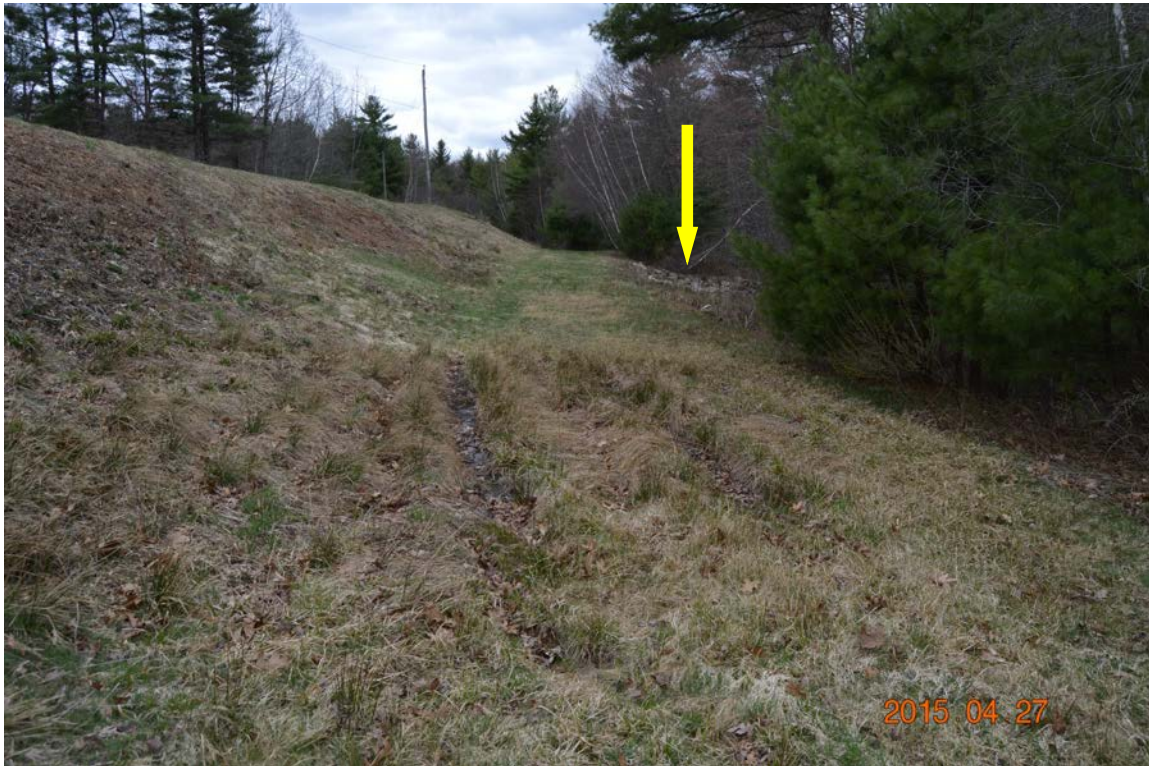
Photo 7c – A continuation of the downstream embankment slope and shelf taken from the sharp corner pointed out in the previous photo. The arrow points to riprap marking the discharge of the low level outlet passing through the dam.

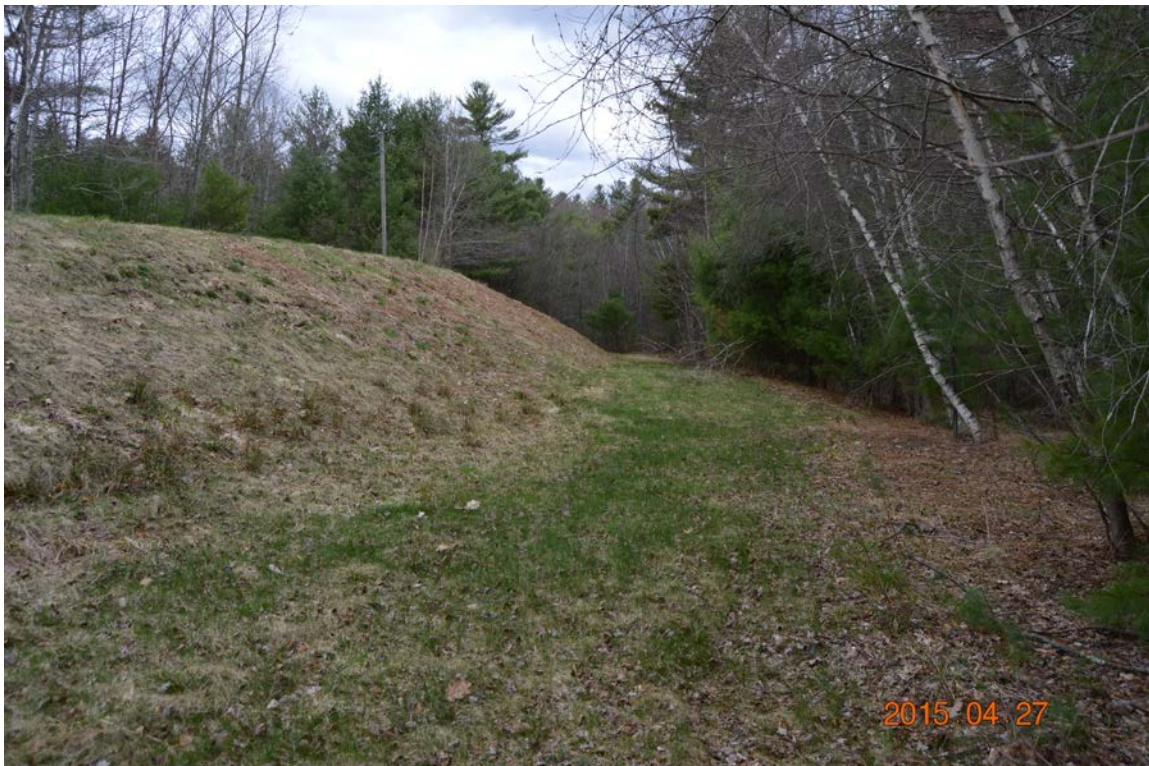
Photo 7d – The downstream area continuing along the embankment from just beyond the low level outlet pointed out in the previous photo. The distant end point in this photo marks the left abutment end of the main dam embankment.

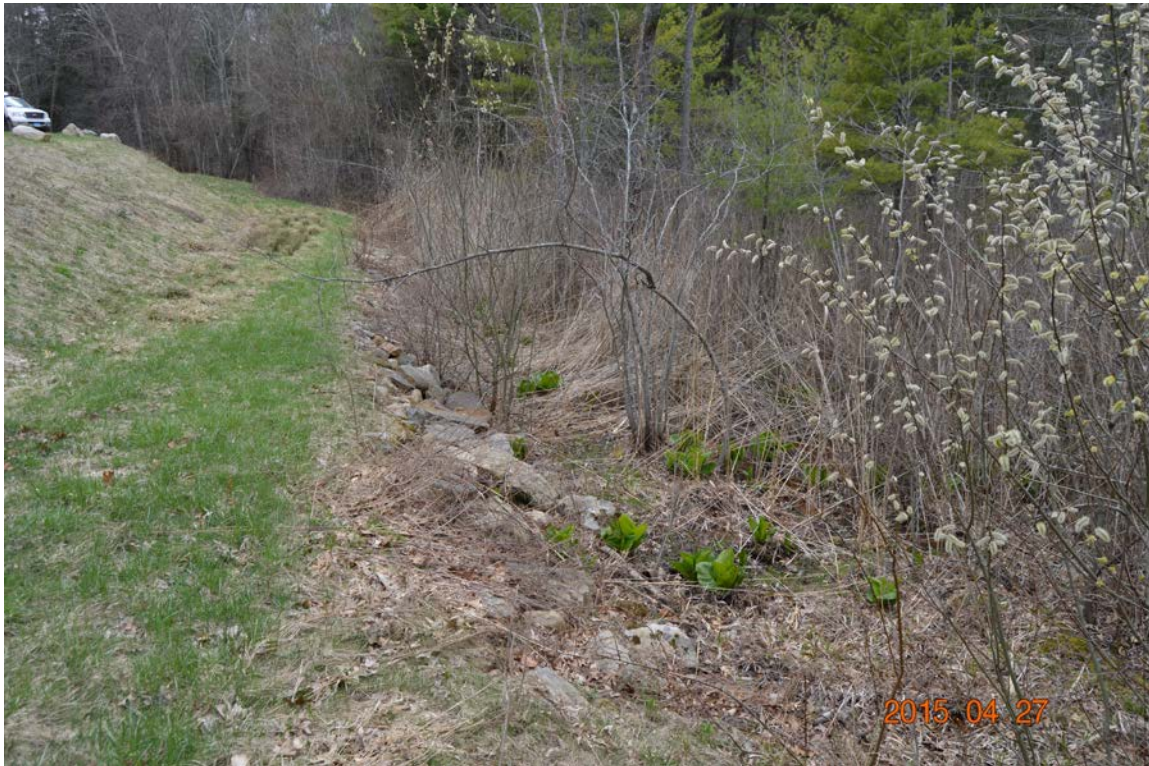
Photo 7e – The downstream embankment of the dike section, again with a base shelf between the toe of the dam and adjacent wetlands.

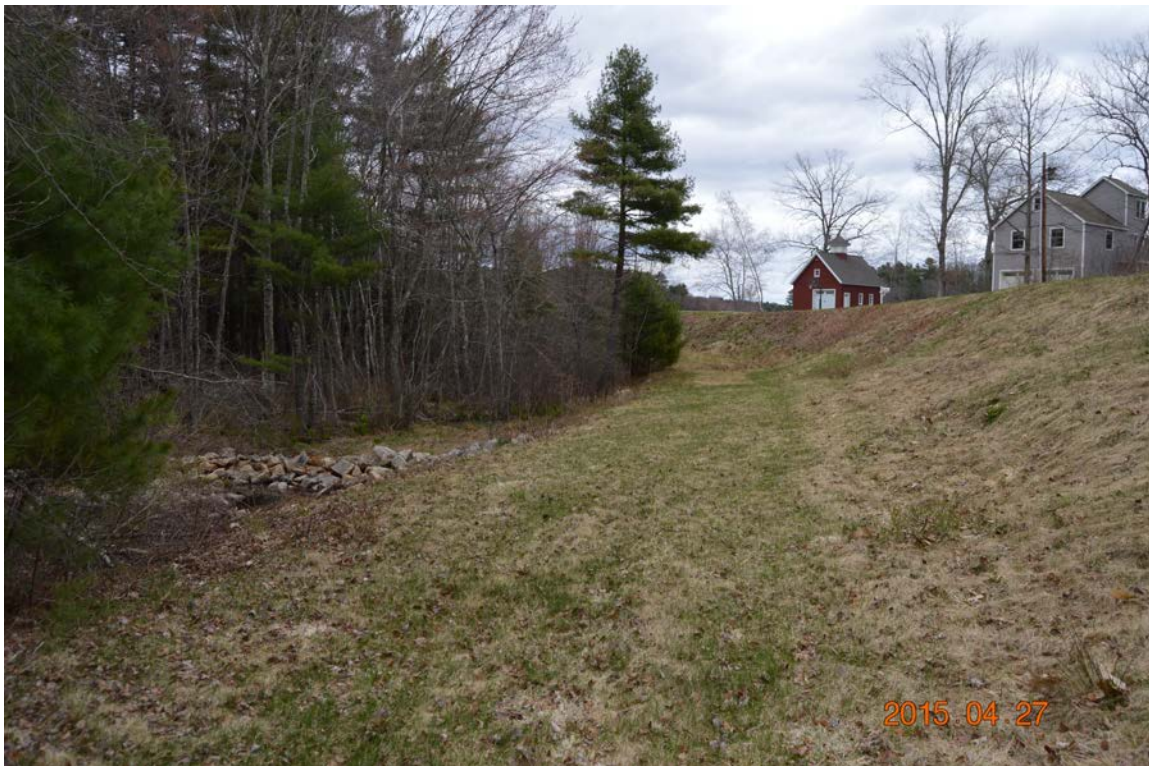
Photo 8a – The downstream face of the embankment as seen from the left abutment area of the dam. The riprap at the left center of the photo represents the discharge point of the low level outlet of the dam. The following photo will show the continuation beyond the sharp curve to the left beyond the red garage.

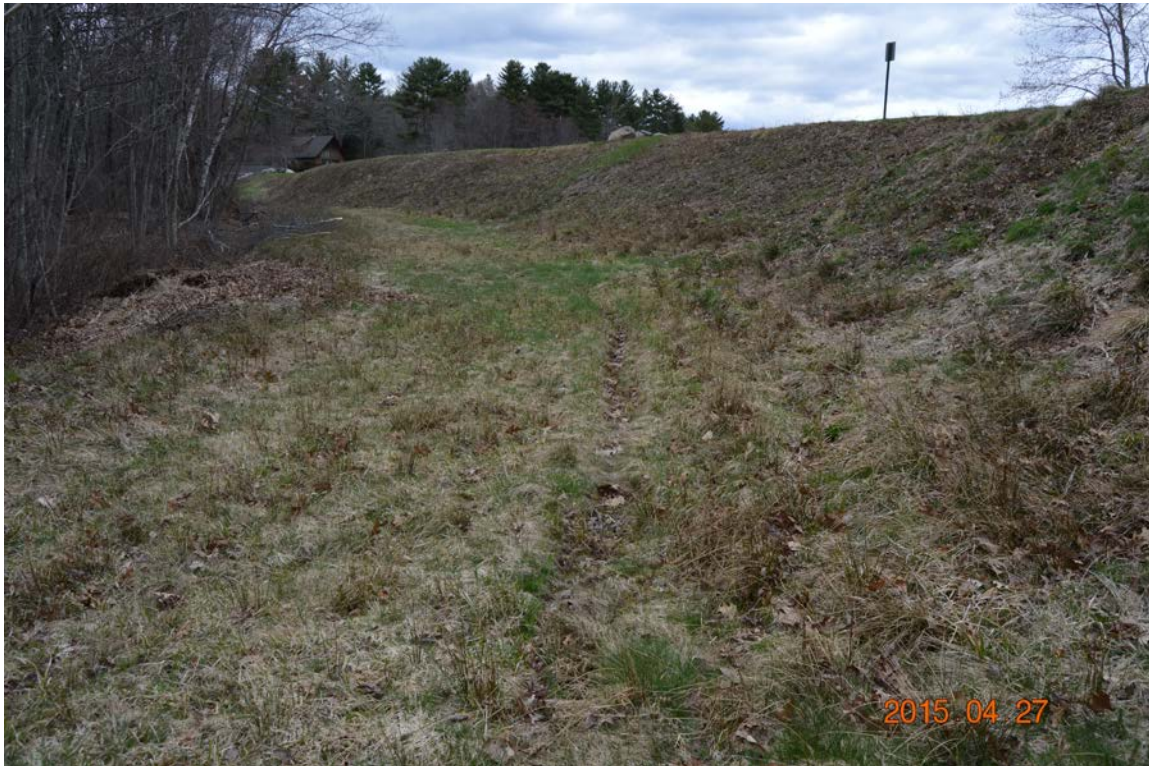
Photo 8b – A view along the downstream side of the main dam embankment, looking northwesterly toward the spillway in the distance, as seen from the sharp turn in the embankment noted in the prior photo.

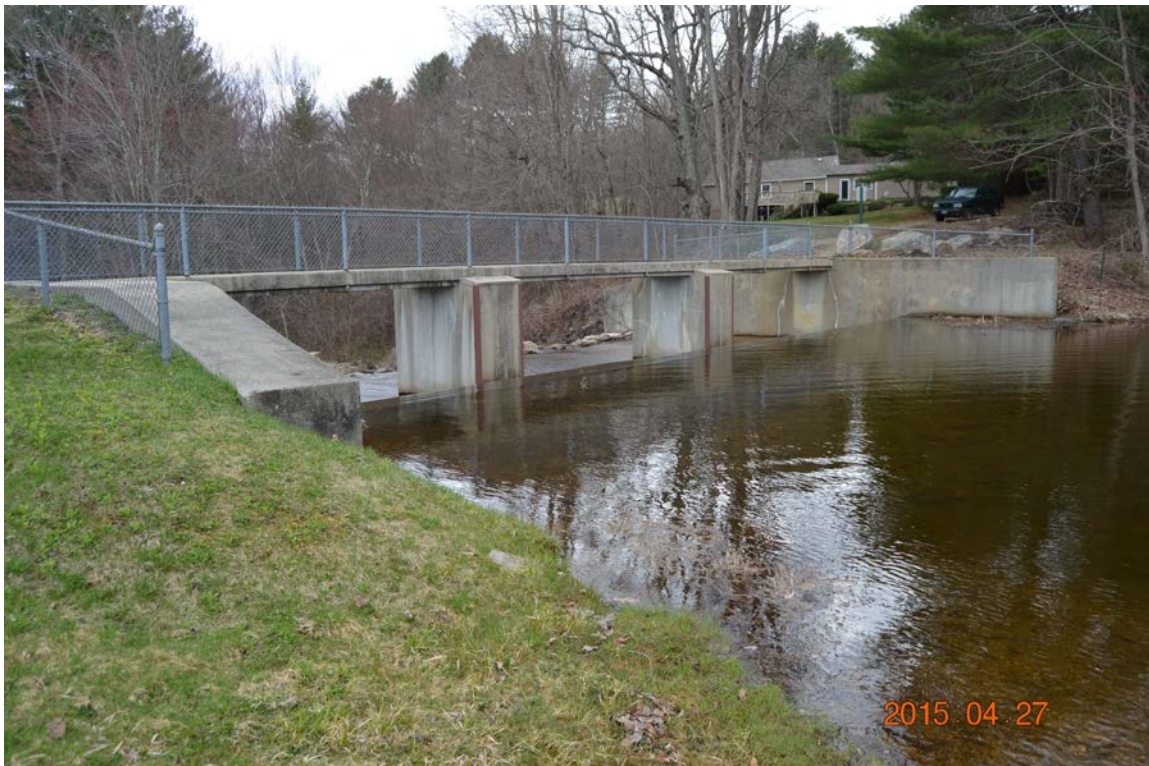
Photo 9a – An upstream view of the spillway from the left side of the lake, during a high water period.

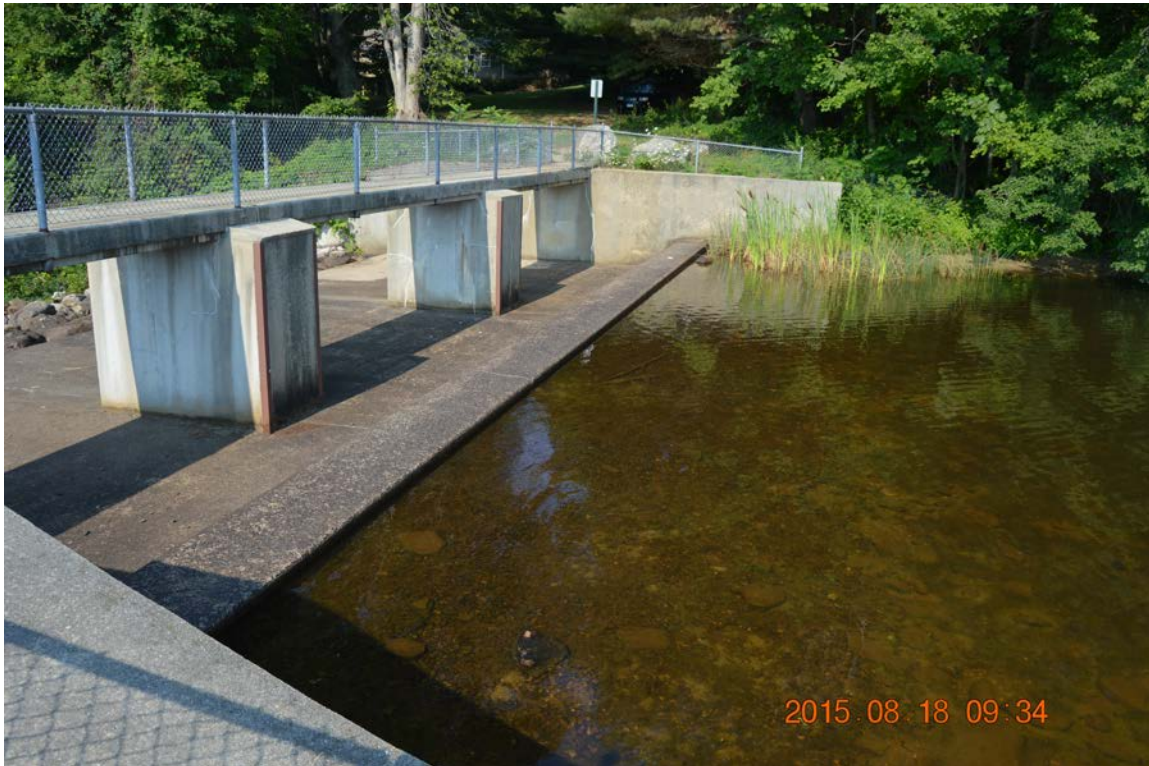
Photo 9b – Another view of the spillway from the upstream left side of the lake, but during a low water level period.

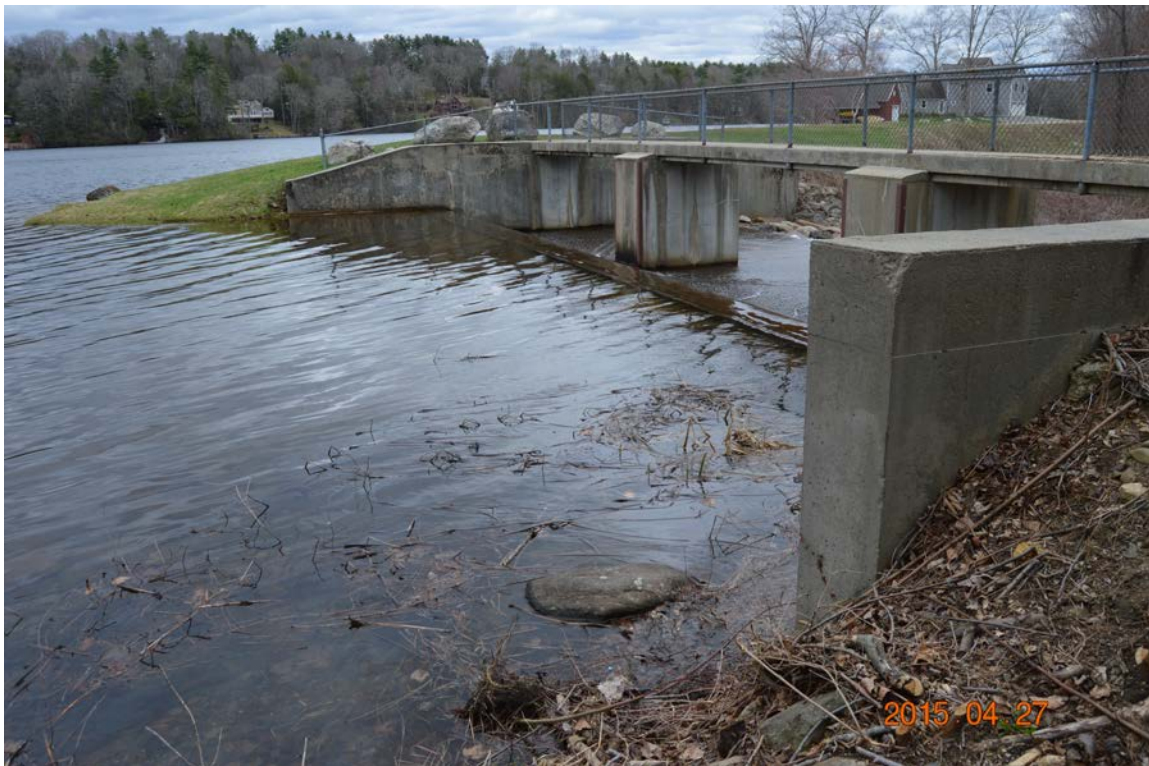
Photo 9c – The spillway as seen from the right upstream side of the lake, looking in a southeasterly direction toward the dam embankment on the far side.
