INSPECTION REPORT

WITCHES WOODS LAKE DAM CT DEEP #16907

CROOKED TRAIL
BUNGEE BROOK
WOODSTOCK, CONNECTICUT

MARCH 2016

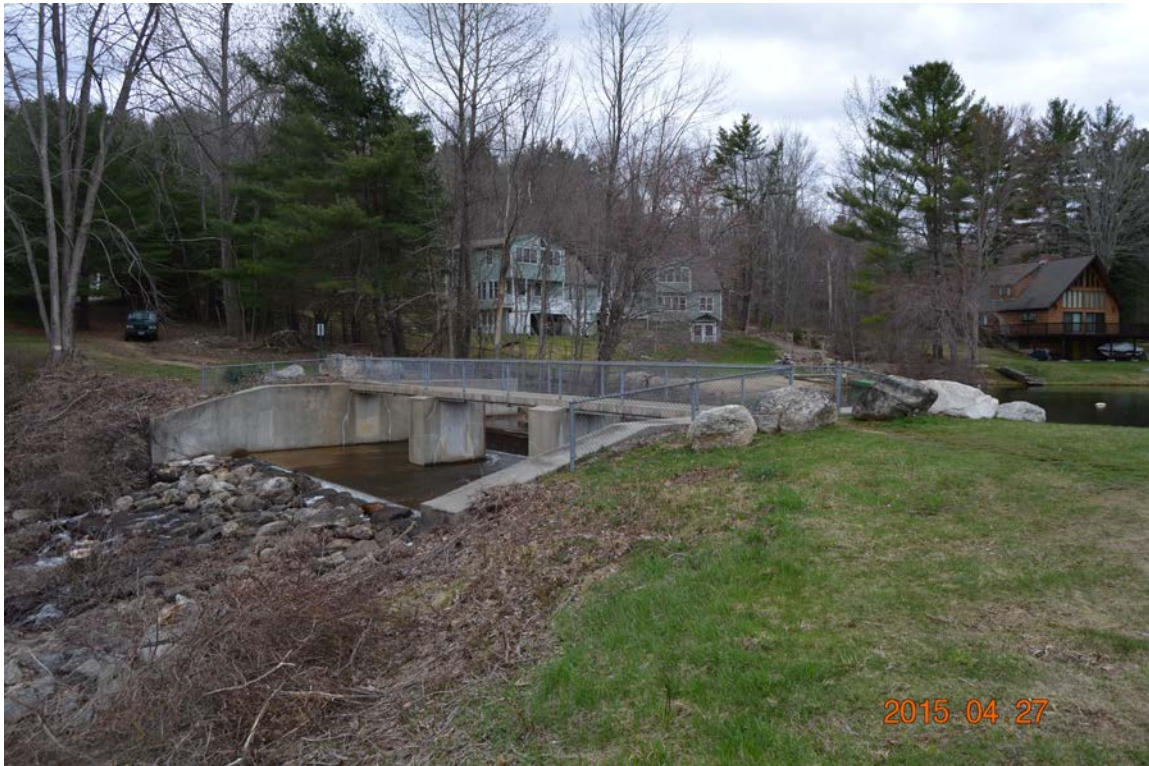
Photo 10a – The spillway as seen from the downstream during an overflow period.

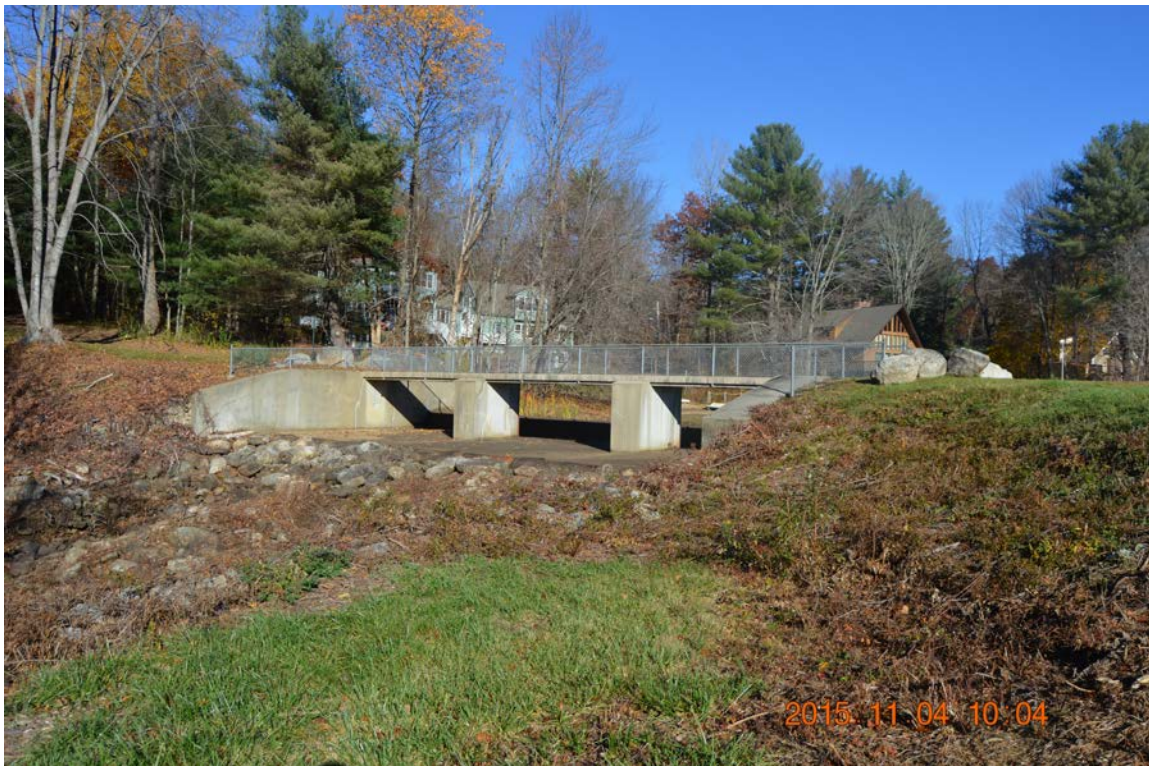
Photo 10b – Another view from the downstream during a low water level period.

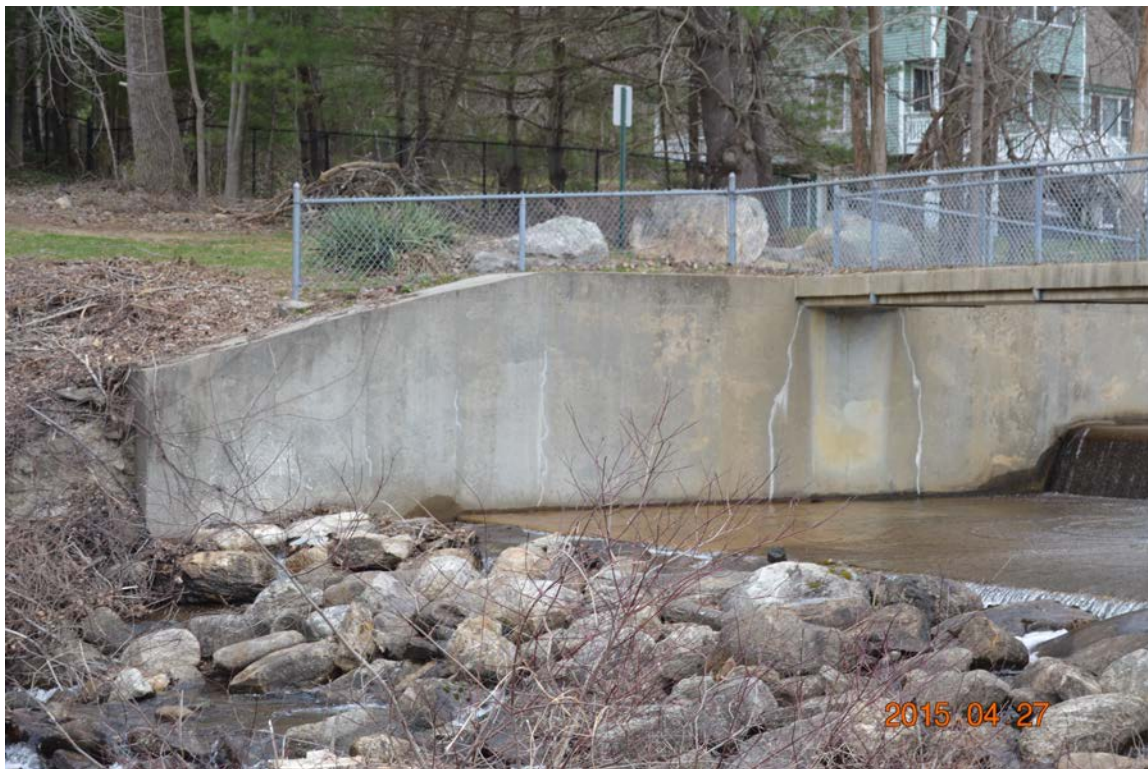
Photo 11b – The lower portion of the right side spillway training wall as seen from the left side of the downstream stilling basin area.

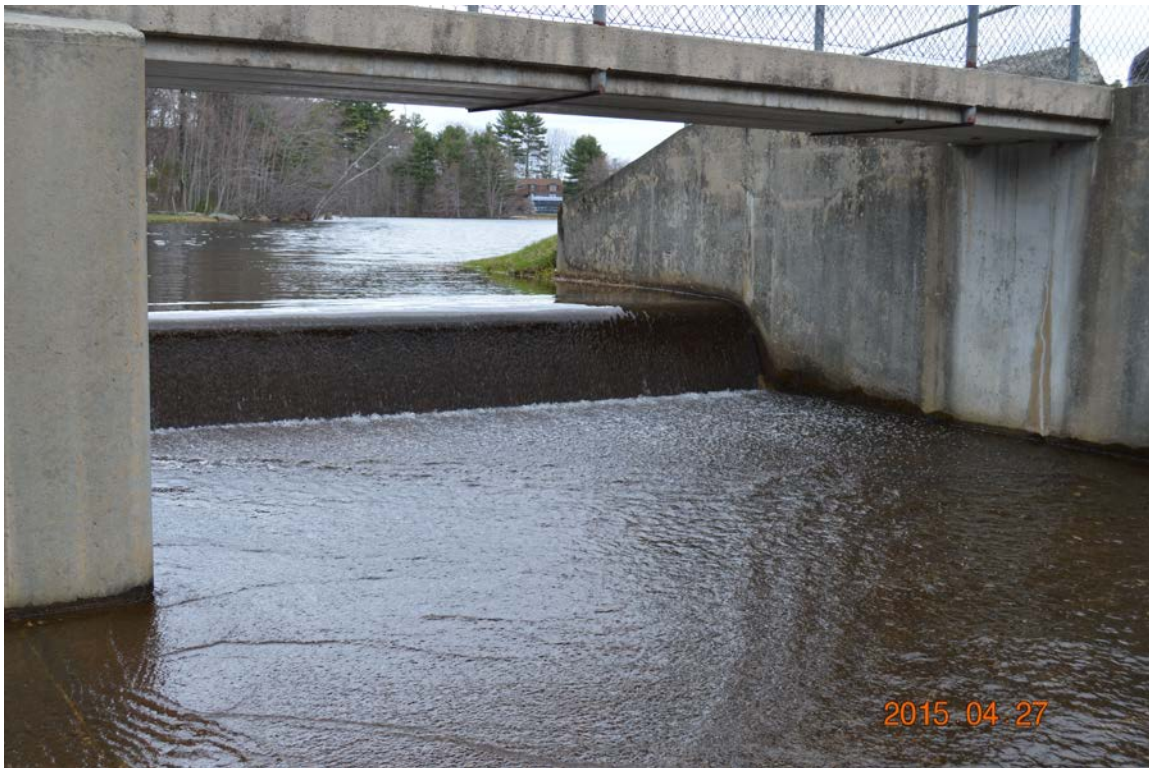
Photo 12a – An overview of the upstream portion of the left training wall

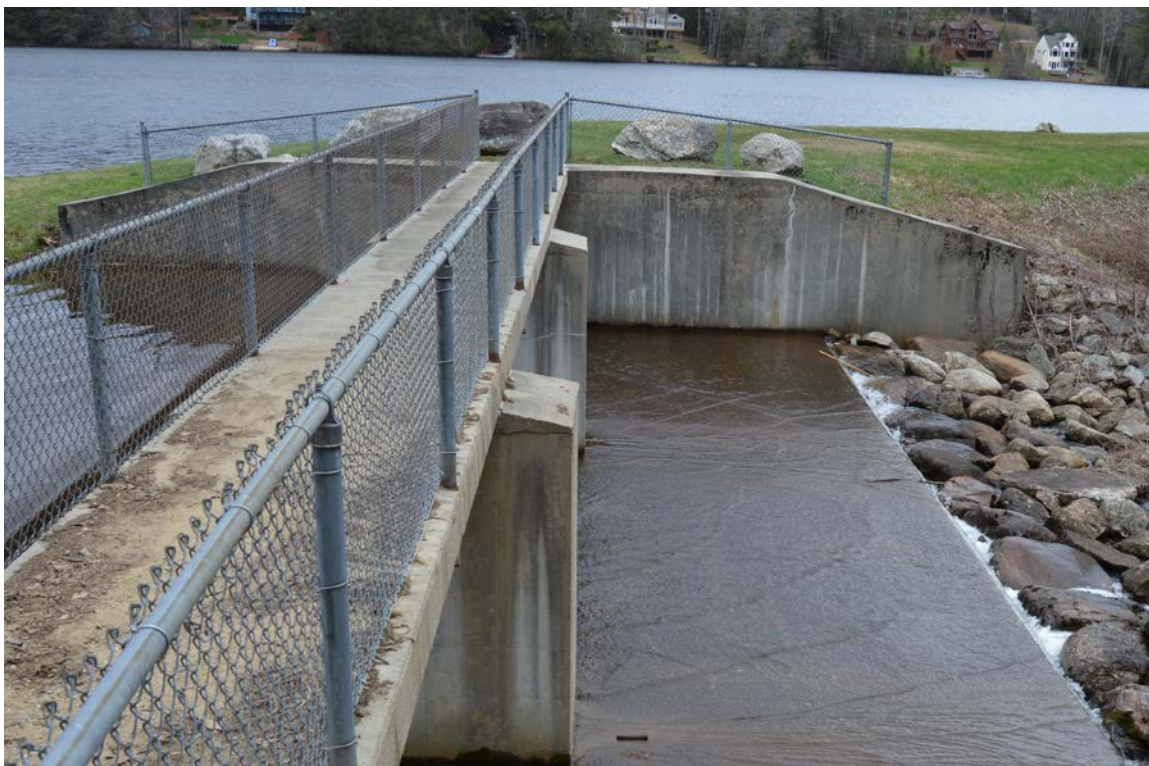
Photo 12b – The lower section of the left spillway training wall.

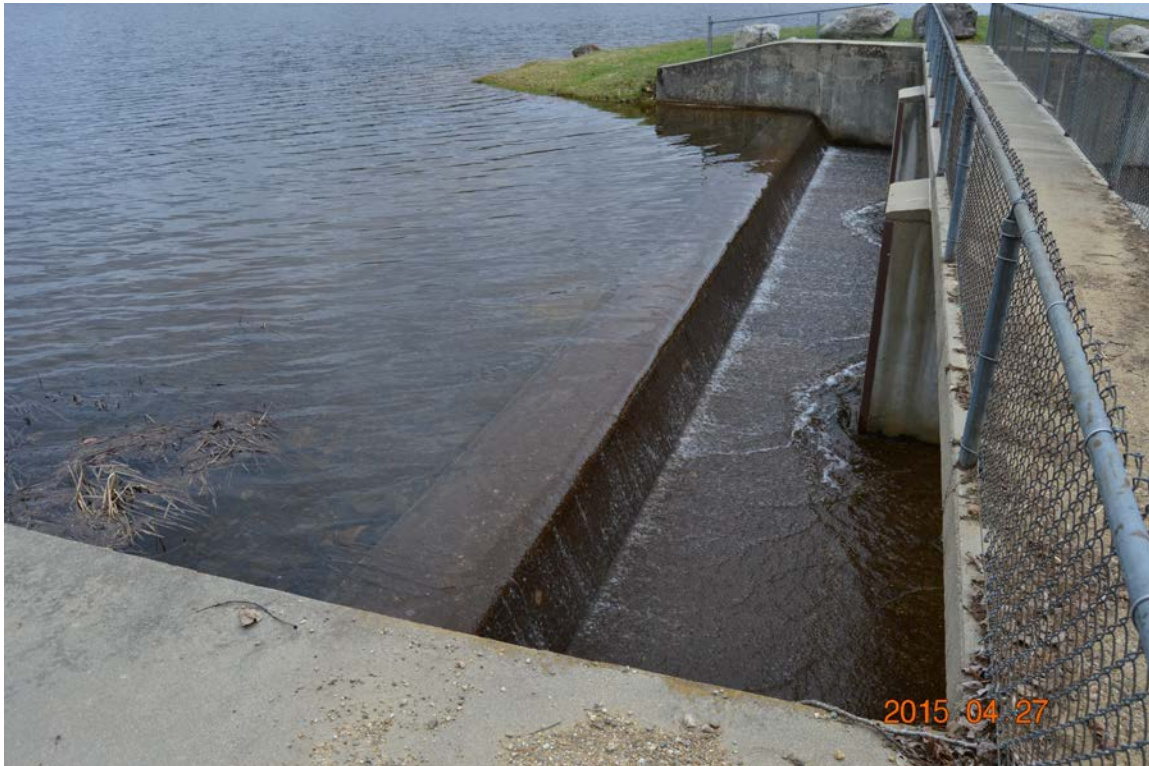
Photo 13a – The weir as seen from the right training wall area during an overflow period.

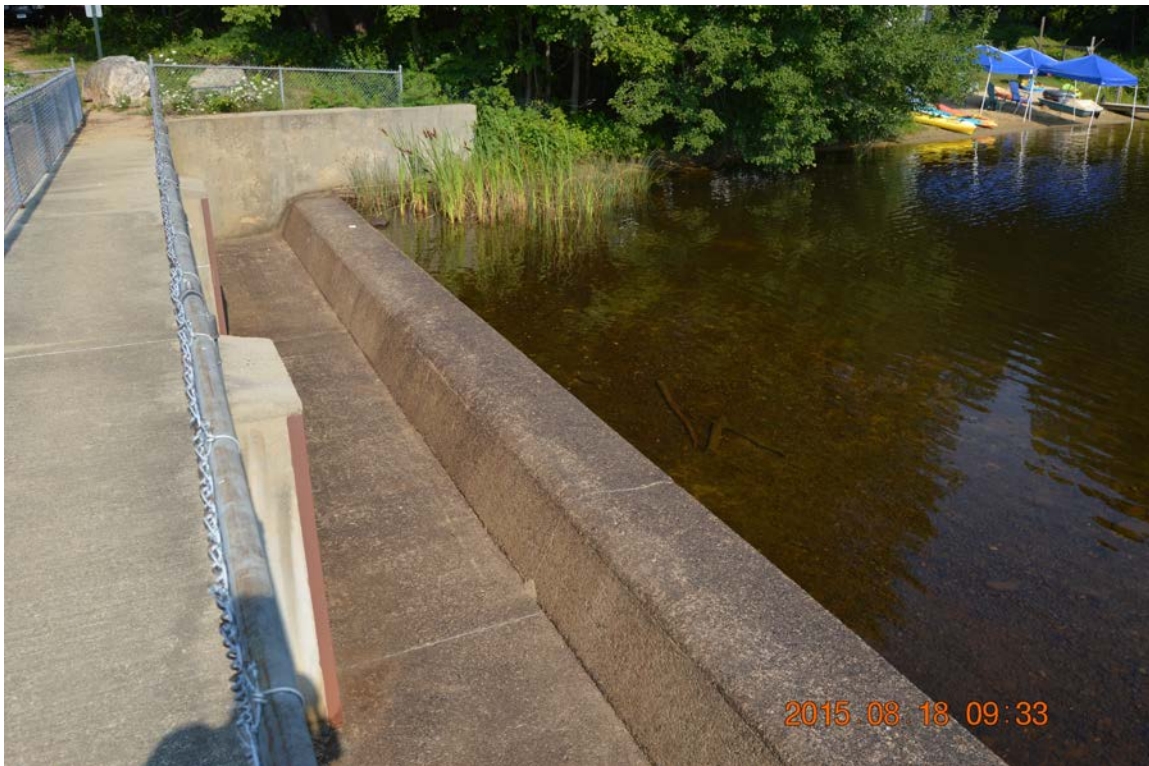
Photo 13b – The weir as seen from its left side during a low water level period. There are two control joints along its length.

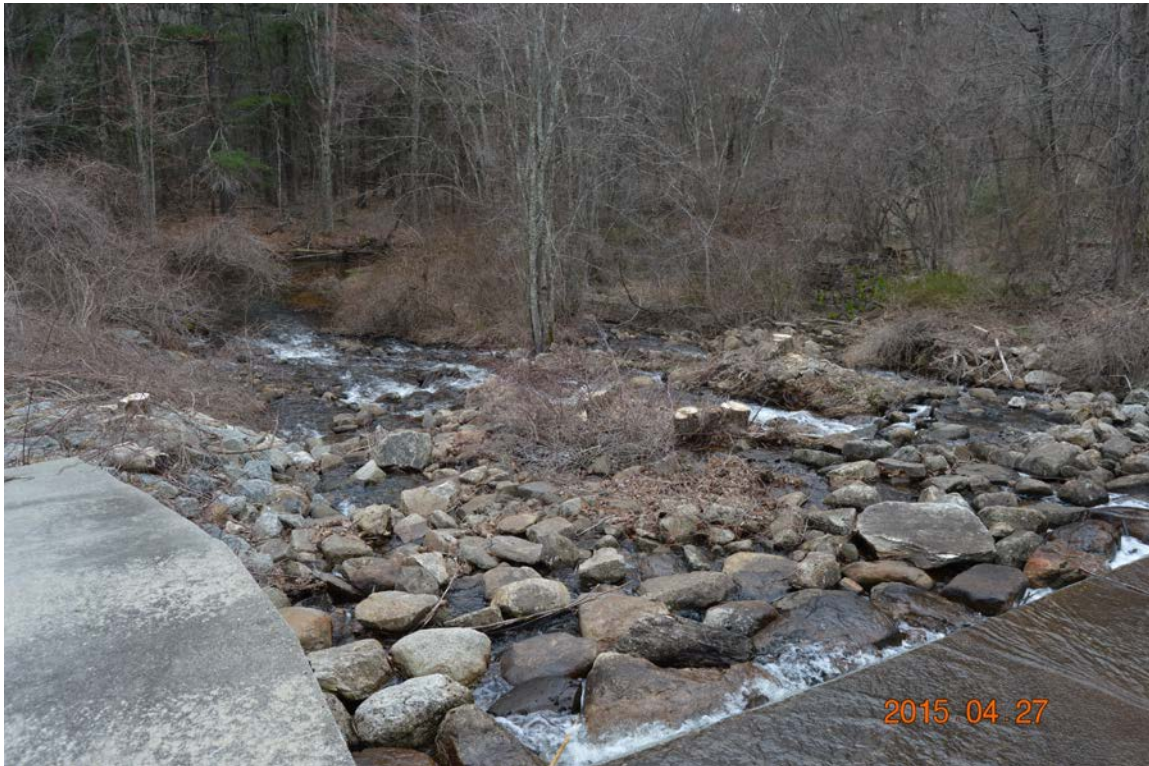
Photos 14 & 15 – An overview of the stilling basin area, as well as a view of the channel downstream of the spillway apron at the bottom right.

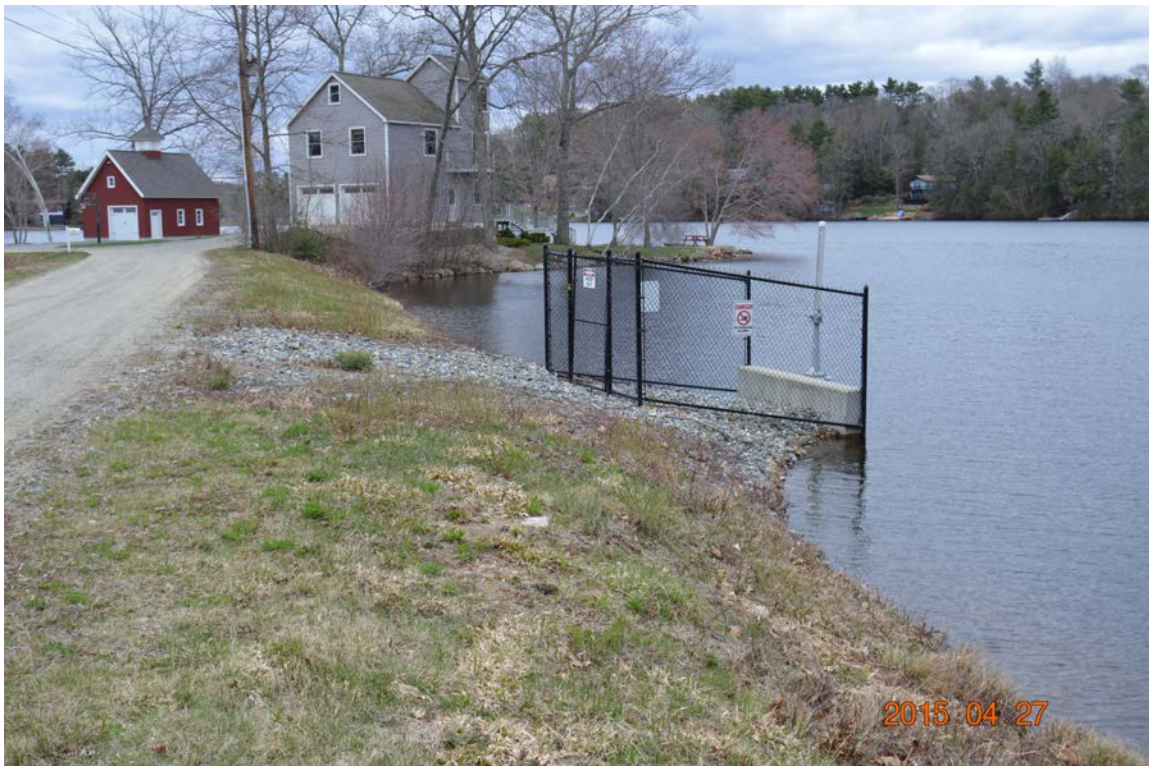
Photo 16 – An overview of the sluice gate structure on the upstream side of the main dam embankment. It consists of a sluice gate set along the vertical upstream side of a concrete wall.

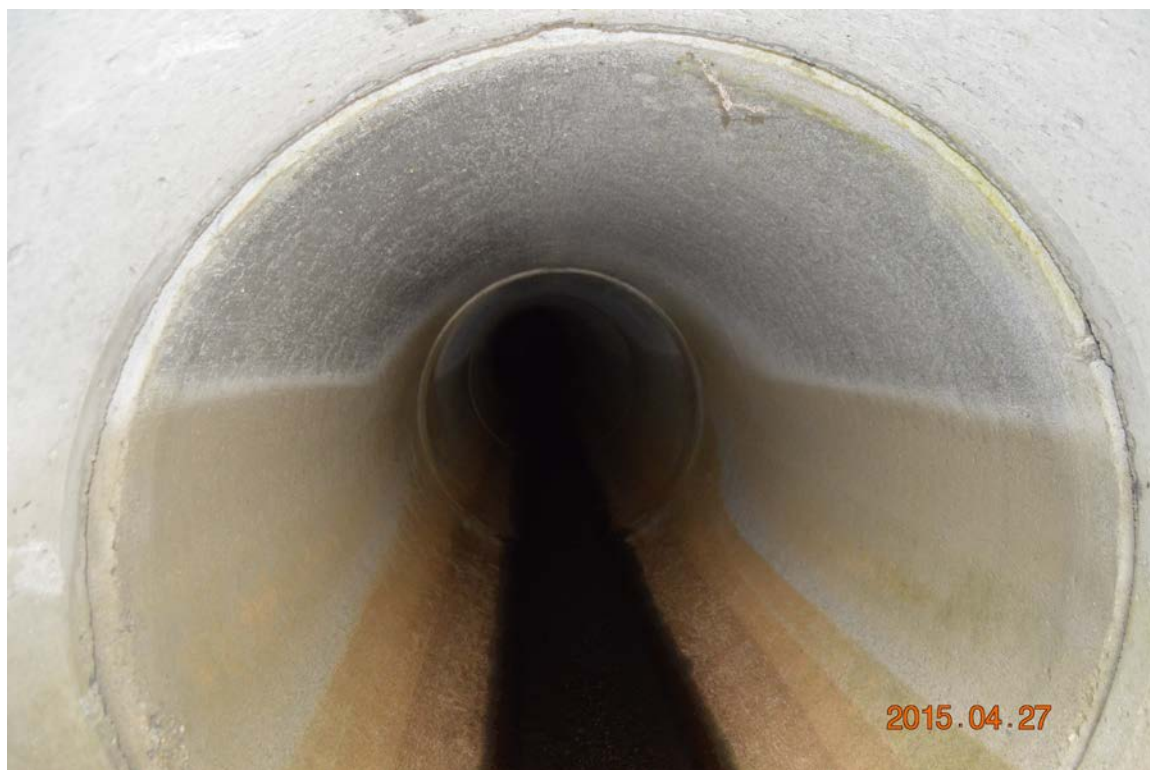
Concrete Condition: The interior of the concrete pipe and the exposed portions of the concrete flared end were in good condition.

Photo 17 – Since there is no gatehouse interior, we have chosen to show the interior of the low level outlet pipe, which is in good condition with no structural issues and no apparent open joints.

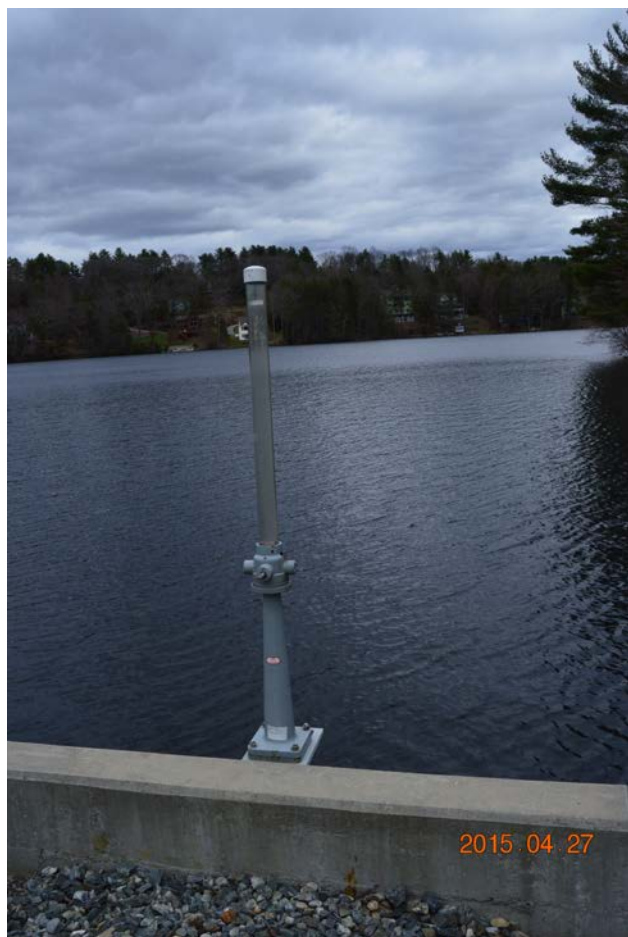
Other: The gate operating / hoisting mechanism appeared in good condition and reportedly was in good working order. The manufacturer's information is attached to the base of the hoist and can be used in the event maintenance becomes necessary.

Photo 18 – The gate hoisting mechanism, a stem with operator attachment.

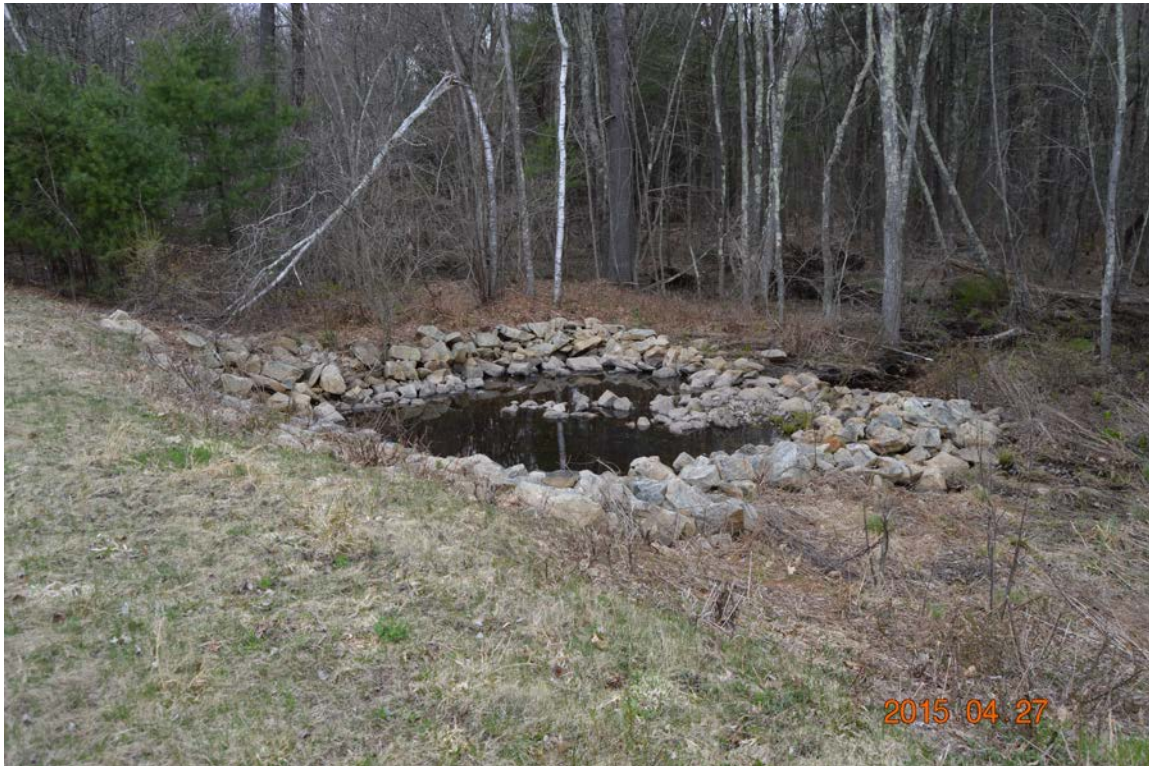
Photo 19a – The discharge area of the low level outlet pipe on the downstream side of the embankment. Note riprap protection to avoid scour.

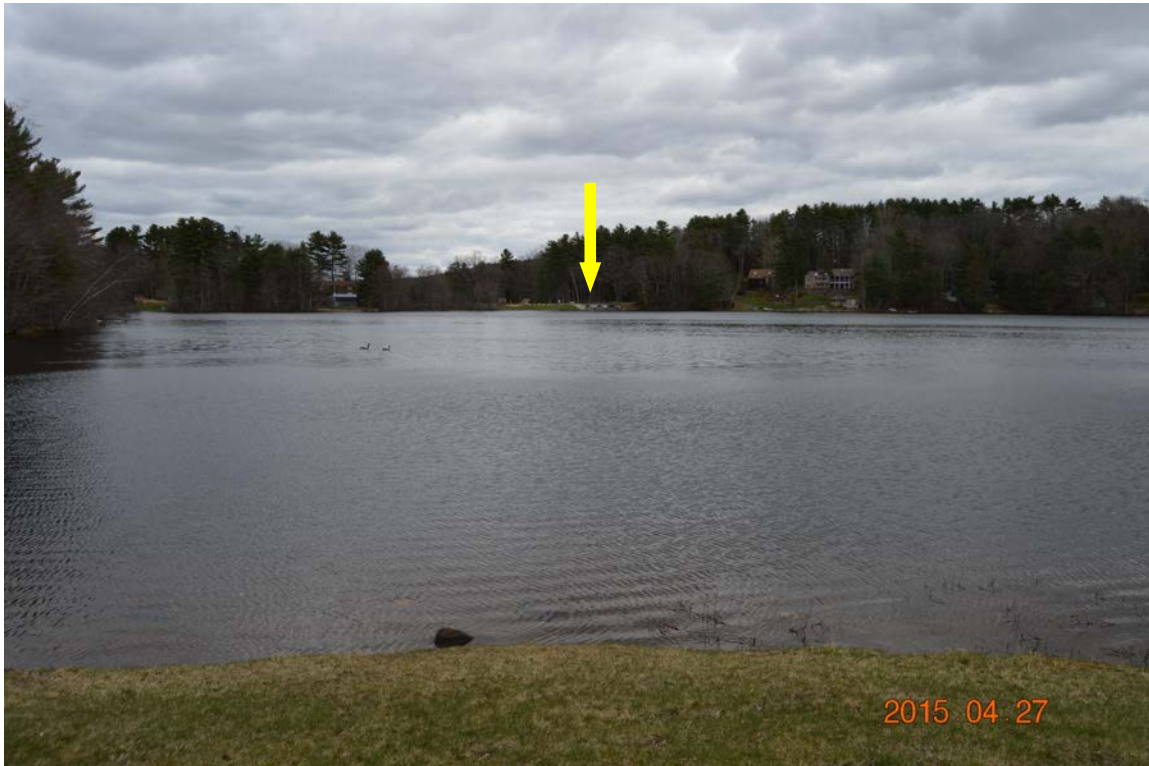
Photo 20 – A view of the lake looking northeasterly from the upstream side of the embankment just left of the spillway. The arrow denotes the location of the spillway for Lake Bunggee, the base of which is submerged beneath the level of Witches Woods Lake.
